## University of Miami Lakeside Village Methods

This investigation was conducted as part of the Landscape Architecture Foundation's 2021 *Case Study Investigation (CSI)* program. CSI matches faculty-student research teams with design practitioners to document the benefits of exemplary high-performing landscape projects. Teams develop methods to quantify environmental, social, and economic benefits and produce Case Study Briefs for LAF's *Landscape Performance Series*.

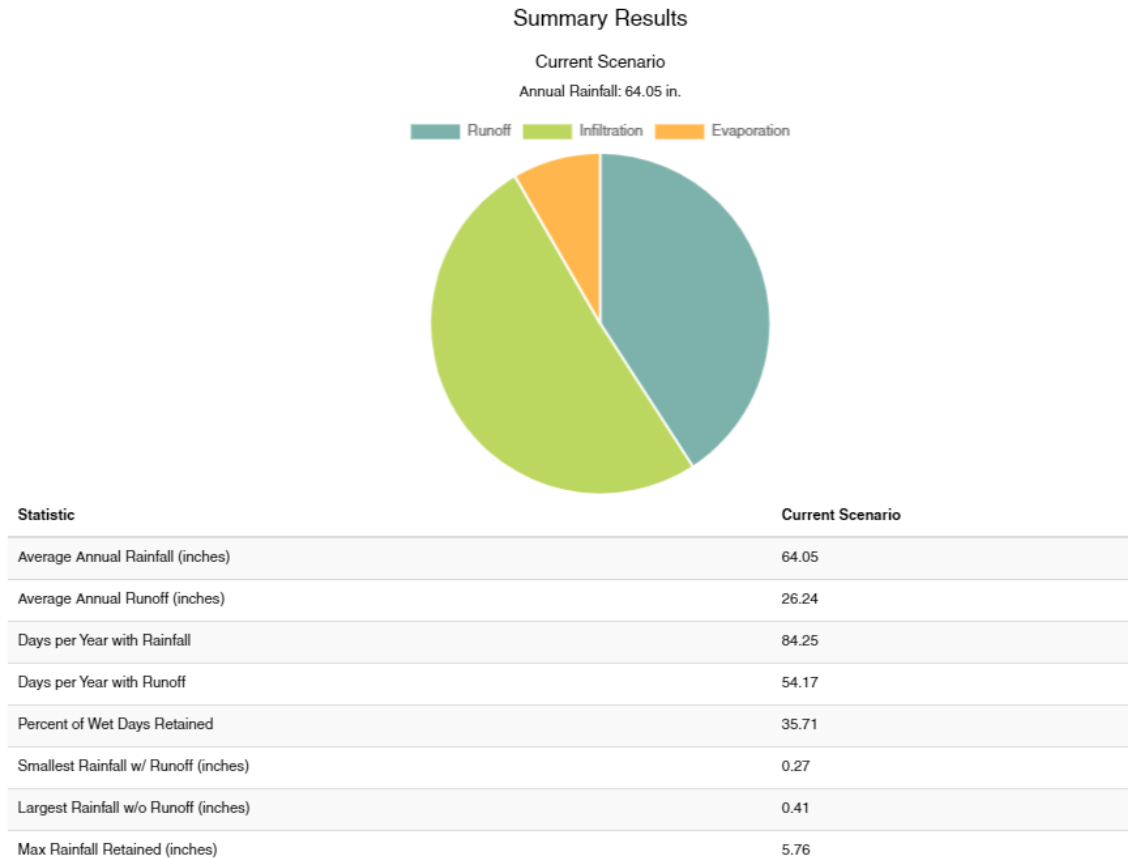
Figure 1: Final results as shown in the National Stormwater Calculator.

**Calculations:** The model results from the National Stormwater Calculator were used to determine the percentage of average annual rainfall captured, infiltrated, and evaporated on-site through LID controls: green roofs and rain gardens.

Annual Rainfall: 64.05 in

Runoff: 26.24 in

$(26.24 \text{ in}/64.05 \text{ in}) * 100 = \mathbf{40.97\%}$

$(37.81 \text{ in}/64.05 \text{ in}) * 100 = \mathbf{59.03\%}$

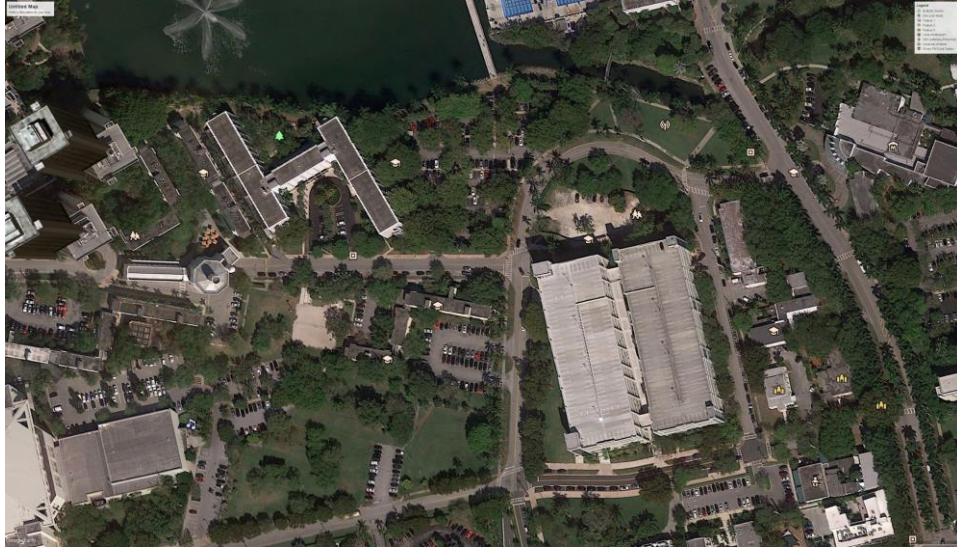
Figure 7: Google Earth Pro image of site in 2017 prior to the construction of UM Lakeside Village. The team utilized this image, and others, to compare the areas of lawn and planting to the areas of lawn and planting currently on the site.

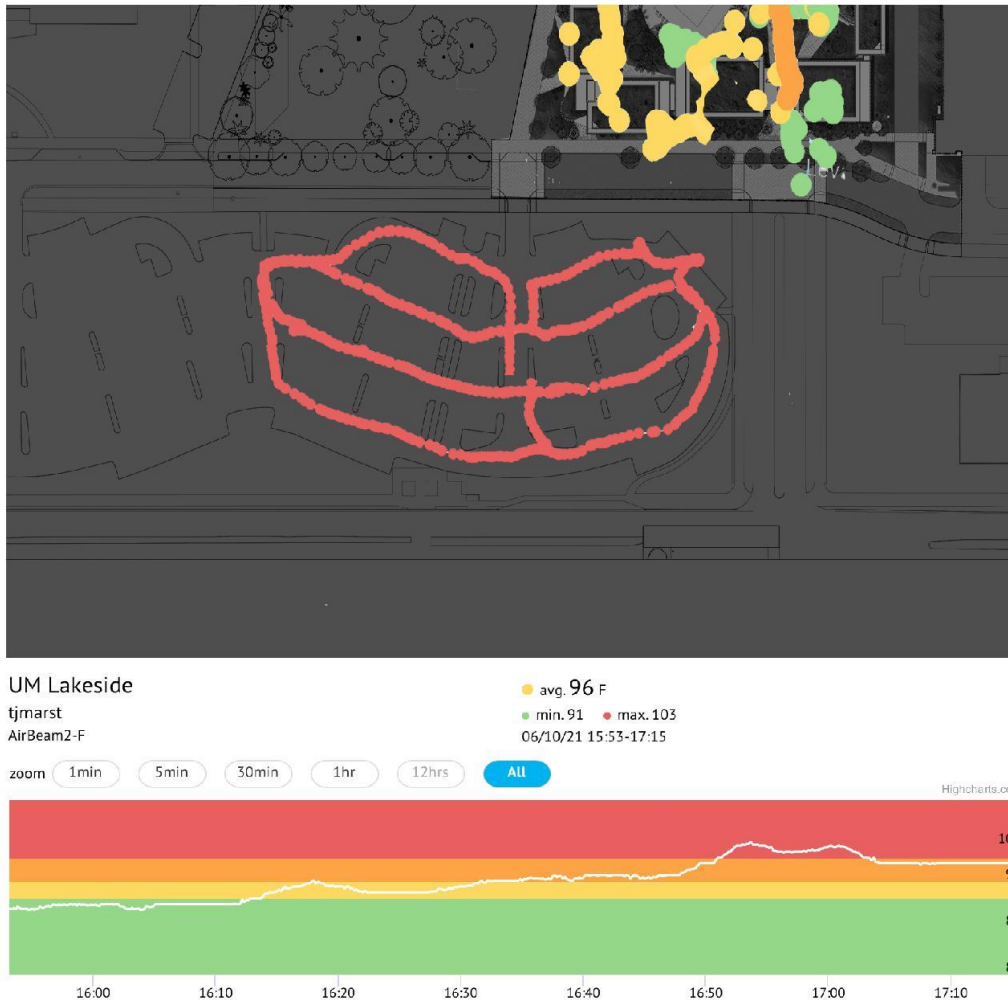
Figure 12: Detail of parking lot locations with temperatures.

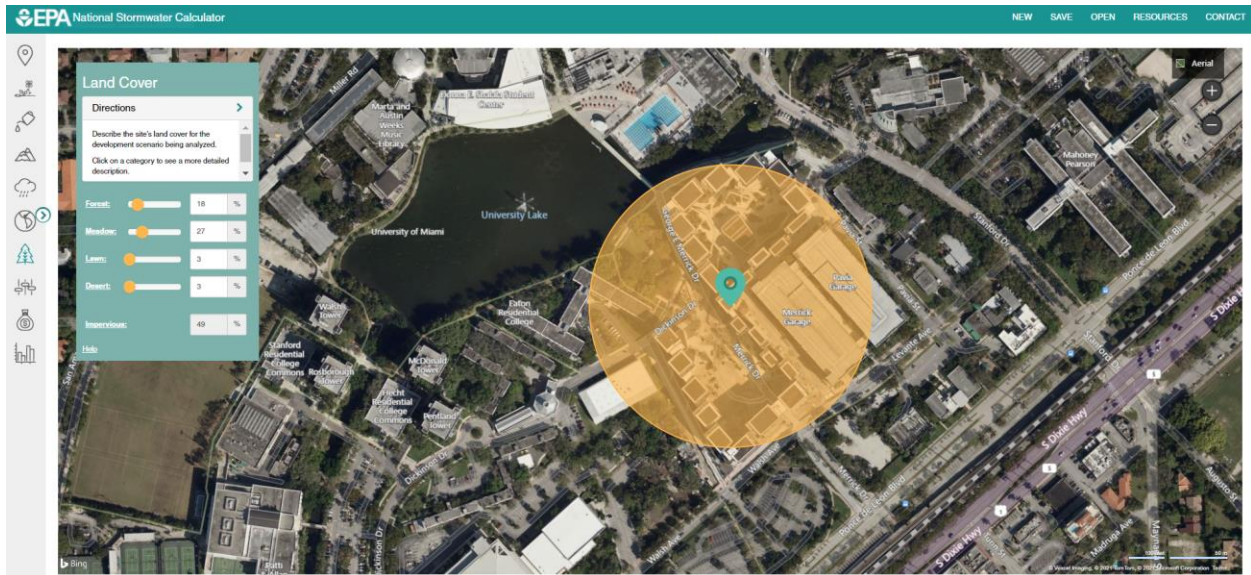
Figure A6: Land Cover (National Stormwater Calculator)

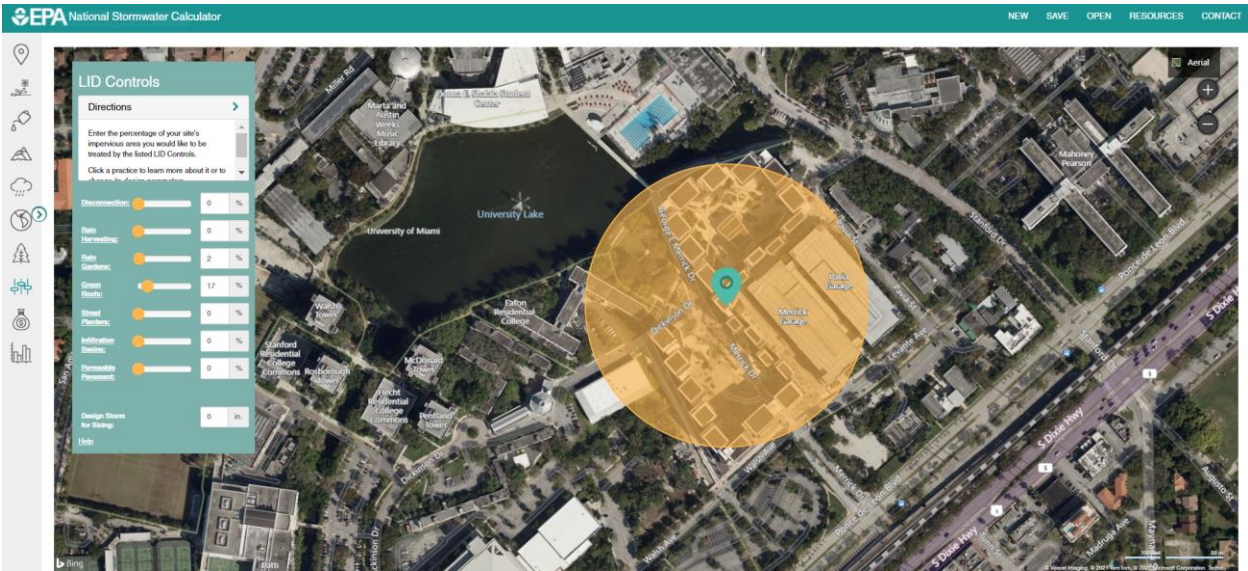
Figure A7: LID Controls (National Stormwater Calculator)

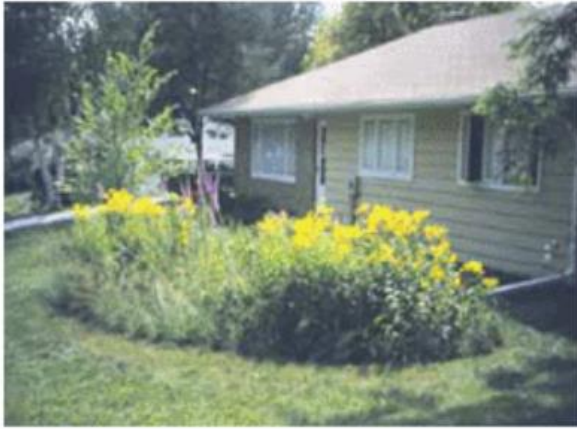
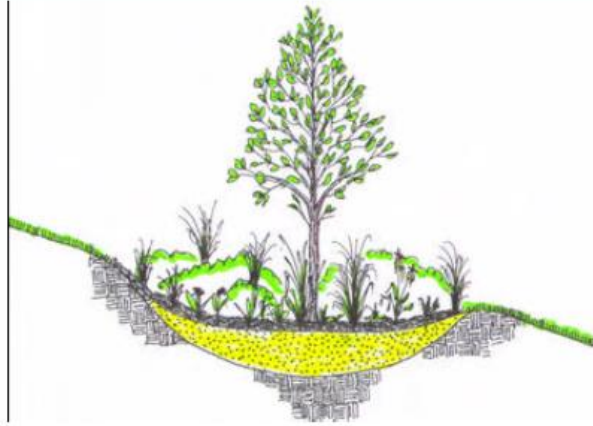
Figure A8: LID Controls - Rain Gardens (National Stormwater Calculator)

Rain Gardens are shallow depressions filled with an engineered soil mix that supports vegetative growth. They are usually used on individual home lots to capture roof runoff.

Typical soil depths range from 6 to 18 inches

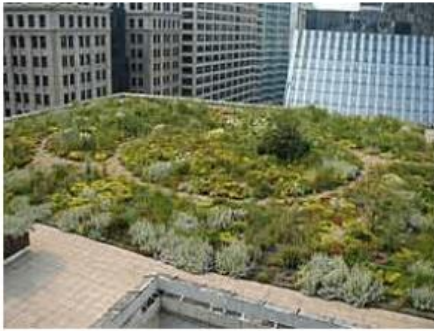
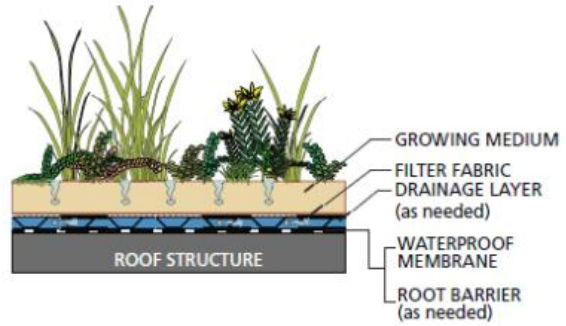
## Green Roofs

Green Roofs (also known as Vegetated Roofs) are bio-retention systems placed on roof surfaces that capture and temporarily store rainwater in a soil growing medium. They consist of a layered system of roofing designed to support plant growth and retain water for plant uptake while preventing ponding on the roof surface.

The thickness used for the growing medium typically ranges from 3 to 6 inches.
