STLCC Forest Park Center for Nursing and Advanced Health Sciences Methods

This investigation was conducted as part of the Landscape Architecture Foundation's 2022 *Case Study Investigation* (CSI) program. CSI matches faculty-student research teams with design practitioners to document the benefits of exemplary high-performing landscape projects. Teams develop methods to quantify environmental, social, and economic benefits and produce Case Study Briefs for LAF's *Landscape Performance Series*.

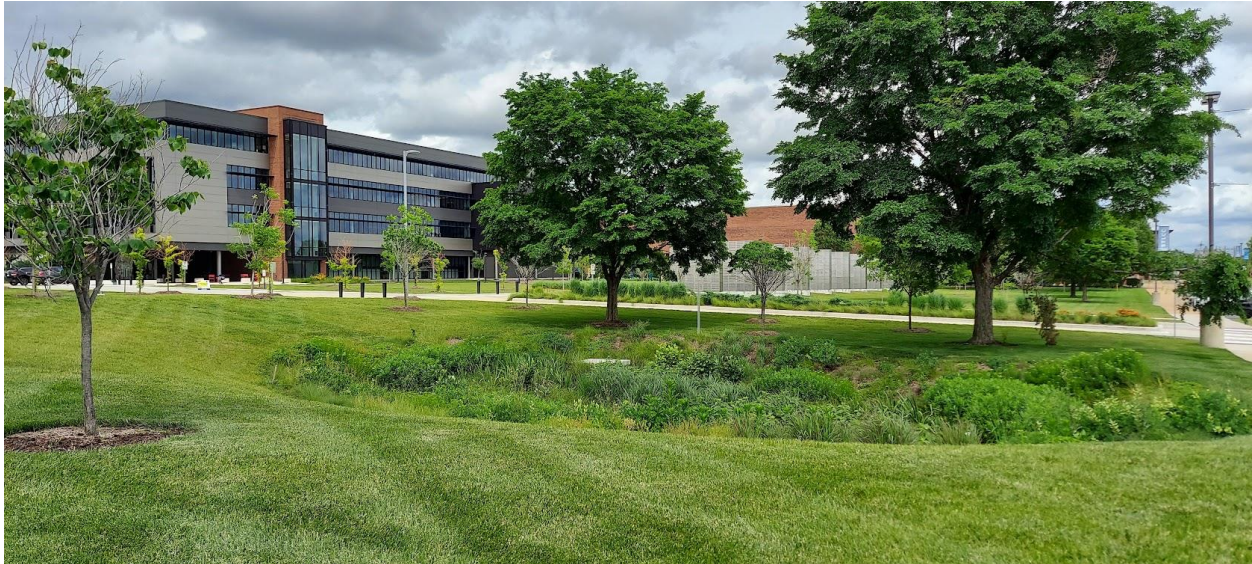
Figure 1. One bioretention basin in the renovated landscape.

The renovated landscape has a total of 1.38 acres of vegetated area (including bioretention and lawn areas). The site saw a 15% decrease in pervious area since approximately 0.76 acres of former lawn became an impervious area. Although the renovated landscape contains a larger impervious area, it includes three bioretention basins (Figure 1) in the remaining vegetated area that help with reducing runoff more than the former lawn.

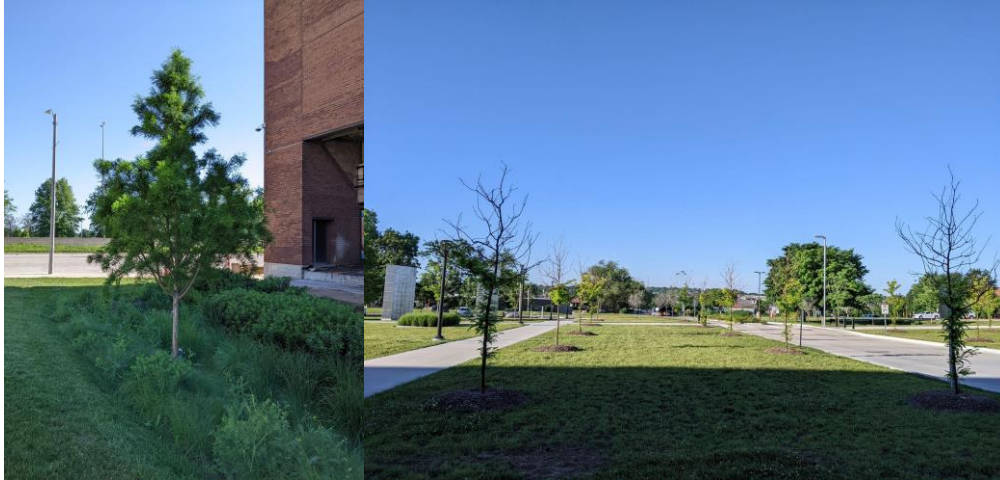
Figure 2. Comparison of tree conditions
(On the right: healthy tree with gator bag located in between buildings; on the left: wilted trees without gator bags in the open area)

- During field visits, we found that most of the trees on the site did not have slow-release watering devices installed, a deviation from the contract documents. The absence of these slow-release devices (gator bags) could be another cause of tree distress. Trees with slow-release watering devices differed in their overall health condition, as they appeared greener and fuller. The amount of sunlight may contribute to better health

outcomes for the trees as well. We observed the healthy trees in locations of less direct sunlight with slow-release devices and reasonably concluded these conditions contributed significantly to their overall well-being (See Figure 2); however, this conclusion needs more testing and observation to understand the actual reasons.

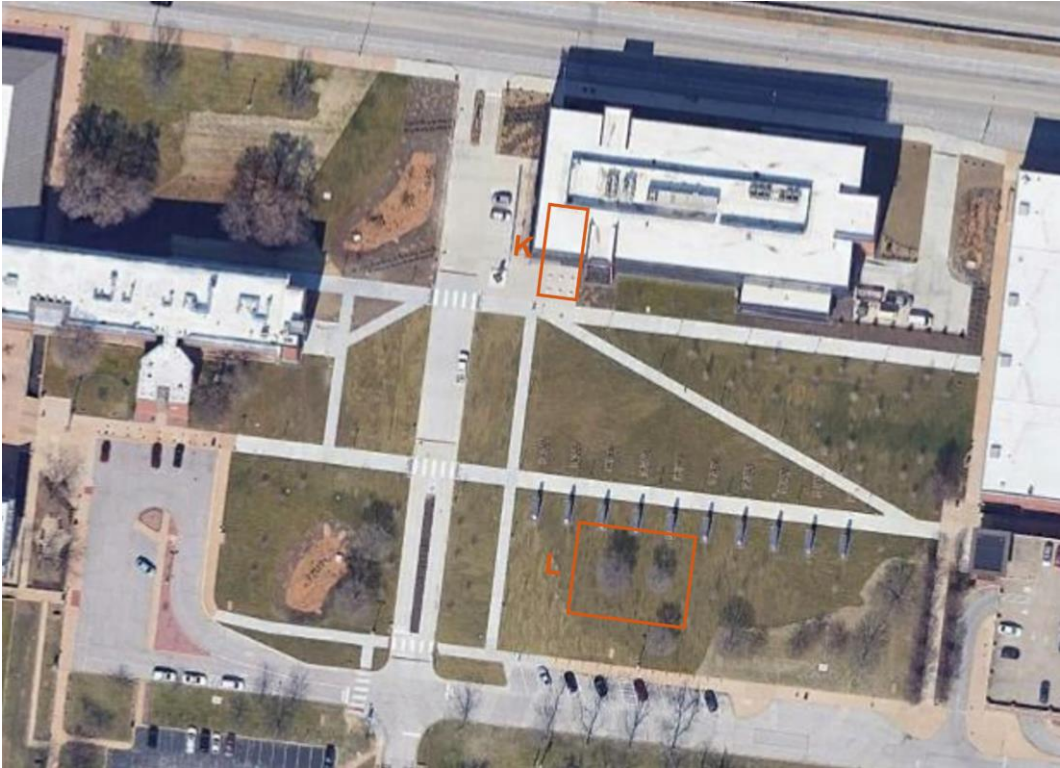
Figure 4. Locations of the observed static behaviors

Outcomes of the observations fit the expectation of where people spend time on the campus – the sitting area with cover and movable furniture next to the building entrance. Table 2 shows that we observed five groups staying at the sitting area (area K in Figure 4) and one sitting on the lawn (area L in Figure 4) for a short period (10 - 90 minutes). Five of the groups had only one person and a group of six people. People used the area for working, gathering, dining, and waiting. Most users came to have lunch during noon.

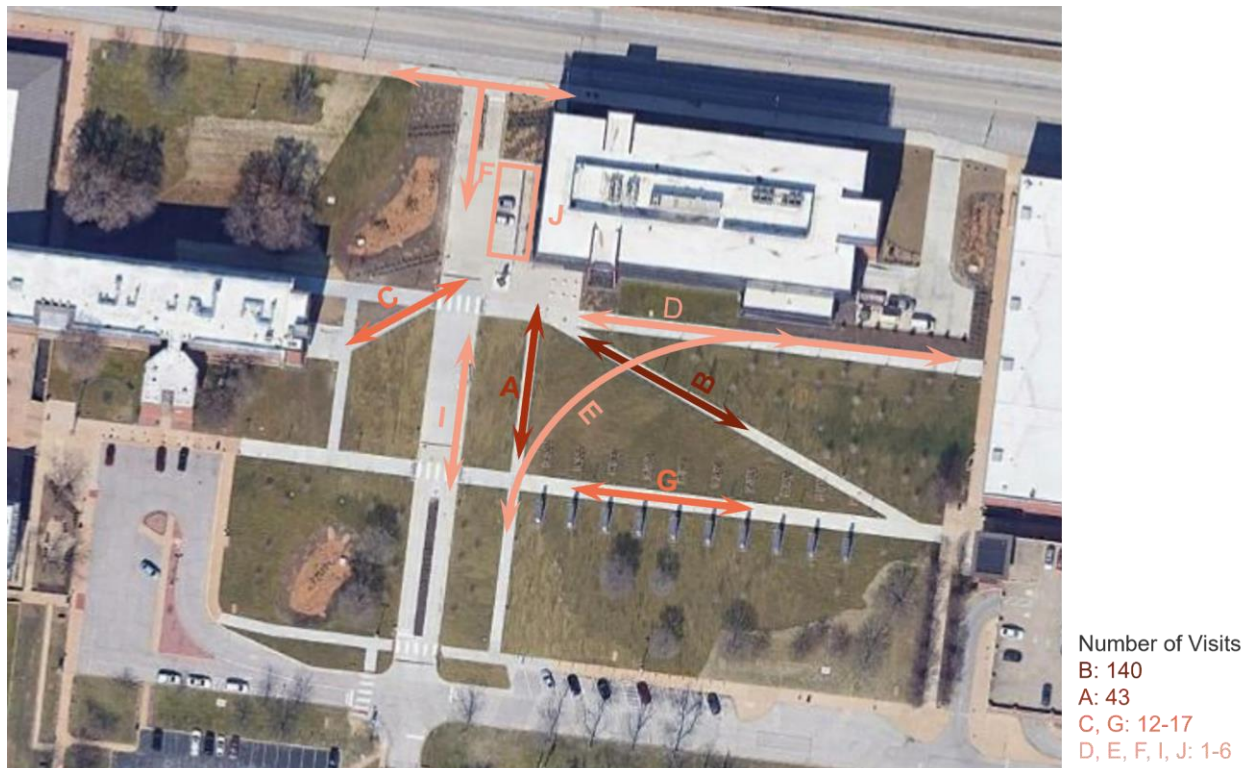
Figure 6. Routes of pedestrian movement by observation

The thickness of the arrows demonstrate the frequency of the usage, the thicker, the more frequent visits observed. The frequency is categorized into four levels based on the visit counts.

We conducted observations on two weekdays during the summer term (the detailed observation time is shown in the method section of the occupancy benefit). Pedestrians arrived during the times between classes, which were in the morning (between 7:00 and 8:00 am) and at noon (between 11:30 am and 12:30 pm). Many of them were those attending classes in the new building. There are generally, however, fewer people around the campus during the summer term, according to the District Division Dean of Health Sciences, Dr. Hubble. The results of the observations are summarized in Figure 6 and the details are shown in Table A1 (Appendix).

According to our observations, most people moved between the new building and the garage in the east on Route B (61% of pedestrians, a total of 140 visits) and the parking lot in the south on Route A (19%, a total of 43 visits). Route I was an alternative path for Route A, especially for those who went from the parking lot to the building, as Route I is the first north-south path they encounter. Route I, however, is the main driveway going through the campus, which might increase potential conflicts between cars and pedestrians. Based on the satellite image before the renovation, the pre-renovated campus did not have a direct sidewalk linking the building to the garage entrance. Route B provides an efficient way of moving around the campus, shown by its high utility. In addition, Route F, a newly created route, connects people on the campus to Oakland Ave., making the campus more accessible for people from the north. Figure 6 shows the main entrance of the campus on Oakland Ave. Our observations demonstrated the pathway design fits the needs of pedestrians' movements, and it created the pathways connecting destinations and enabling people to move efficiently.

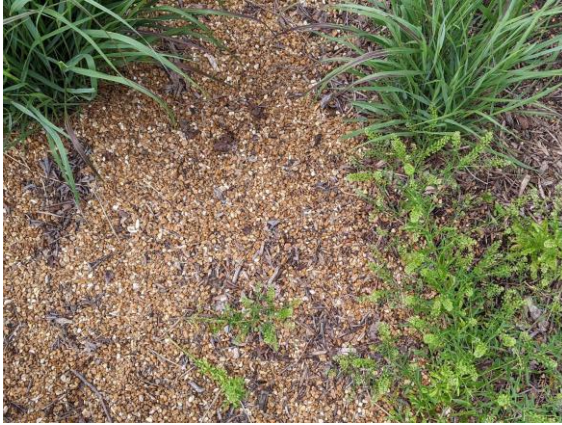
Fig 10. The 3/8" Meramec gravel cover in the bioretention garden area.

The renovated landscape has a more densely planted area; however, we measured a rather higher temperature on the 3/8" Meramec gravel cover inside the bioretention area (Figure 10). We had two points measuring this material, the temperature was 84.2 °F and 87.9°F. The temperature was slightly lower than but almost the same as the average pavement surface temperature, 87.7 °F. As a result, the average temperature of the densely planted area increased. This layer, the Meramec gravel, is required by St. Louis City code. Although reducing temperature is not the primary goal of implementing bioretention gardens, it is a point that can be improved to create a comfortable environment.
