## Gulf State Park Master Plan and Phase 1 Methods

This investigation was conducted as part of the Landscape Architecture Foundation's 2022 *Case Study Investigation (CSI)* program. CSI matches faculty-student research teams with design practitioners to document the benefits of exemplary high-performing landscape projects. Teams develop methods to quantify environmental, social, and economic benefits and produce Case Study Briefs for LAF's *Landscape Performance Series*.

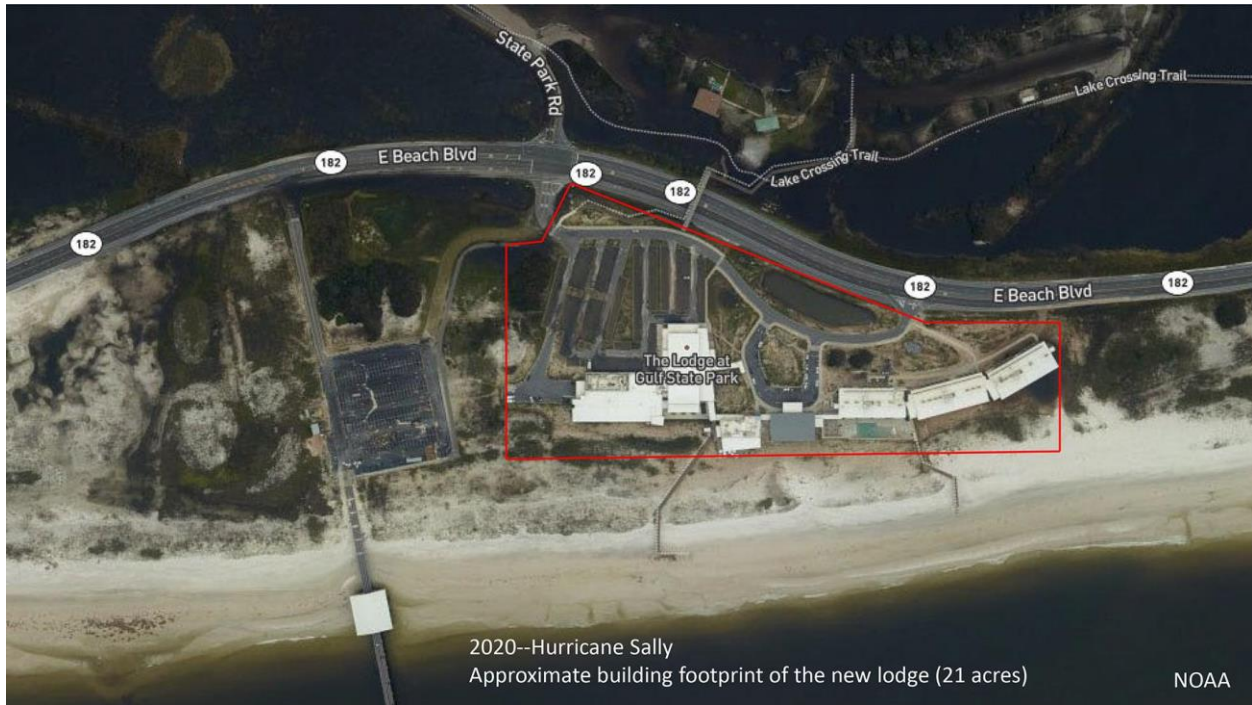
Figure 2. Approximate building footprint of the new lodge (NOAA, 2020).

The new facility is rebuilt on a smaller site than the previous lodge of 21 acres (8.5 ha) vs. 30 acres (12.1 ha) to allow for additional dune restoration (Figures 2 & 3). In addition to overnight accommodations, the facility is a meeting space for mid-sized groups. The landscape is designed with native plantings to enhance and restore the surrounding dune ecosystem.

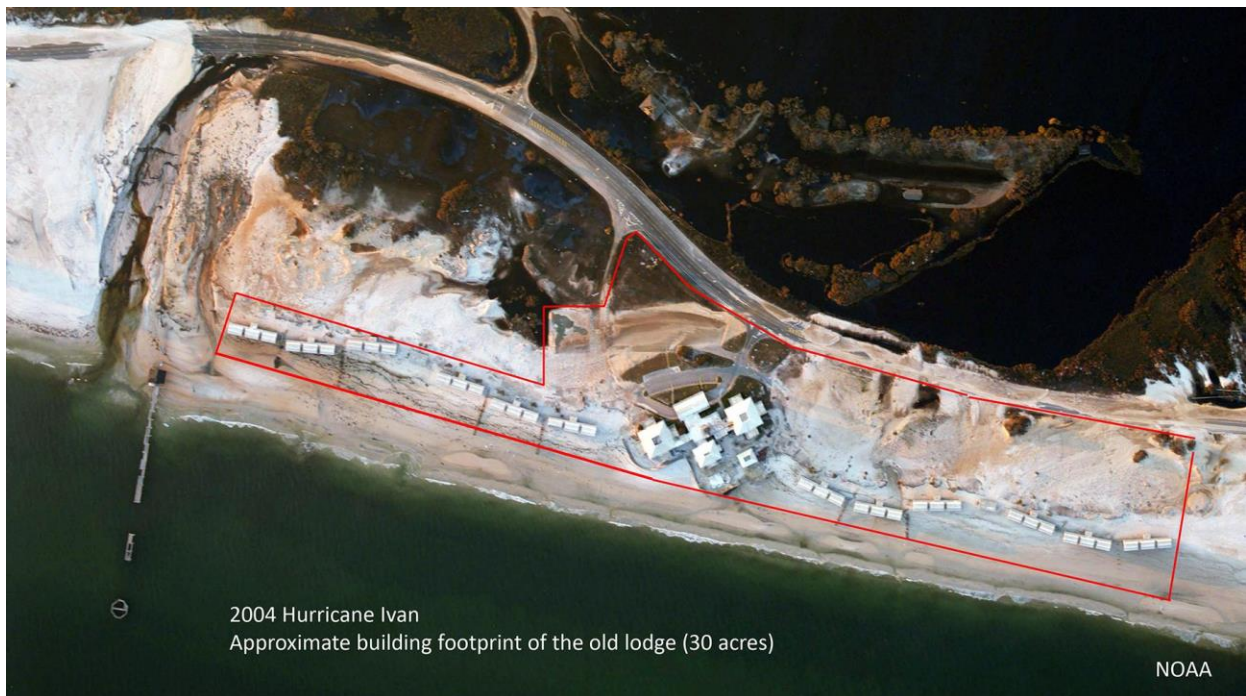
Figure 3. Approximate building footprint of the old lodge (NOAA, 2004).

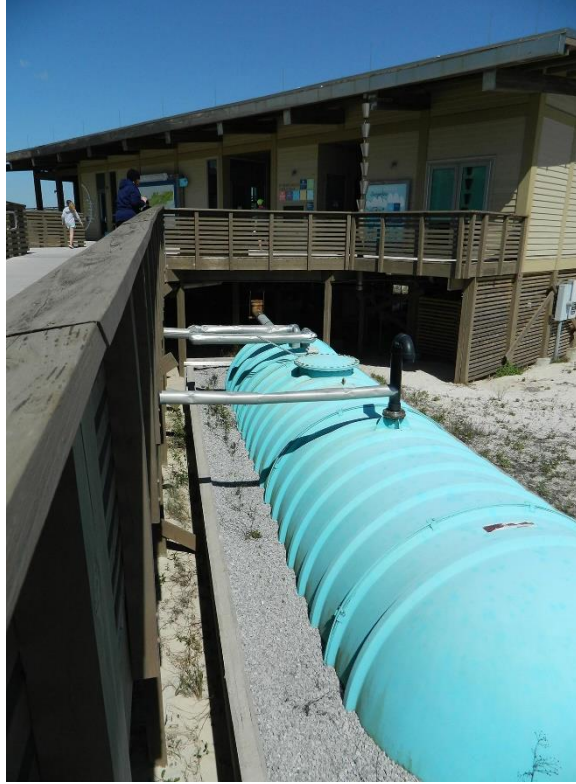
Figure 4. 11,000-gallon (41,640 L) cistern at the GSP Interpretive Center (LeBleu, 2022).

105% of the GSP Interpretive Center's water is collected from rainwater and stored in an 11,000-gallon (41,640 L) cistern (Figure 4). With an inch of rain, the roofs and gutters of the Interpretive Center can gather over 4,000 gallons (15,142 L). The cistern captures about 200,000 gallons (757,082 L) of water per year, and a series of decorative rain chains help direct the rainwater to the cistern (Figure 5). A kiosk on the exterior of the building shows how the Center is using water in real time.

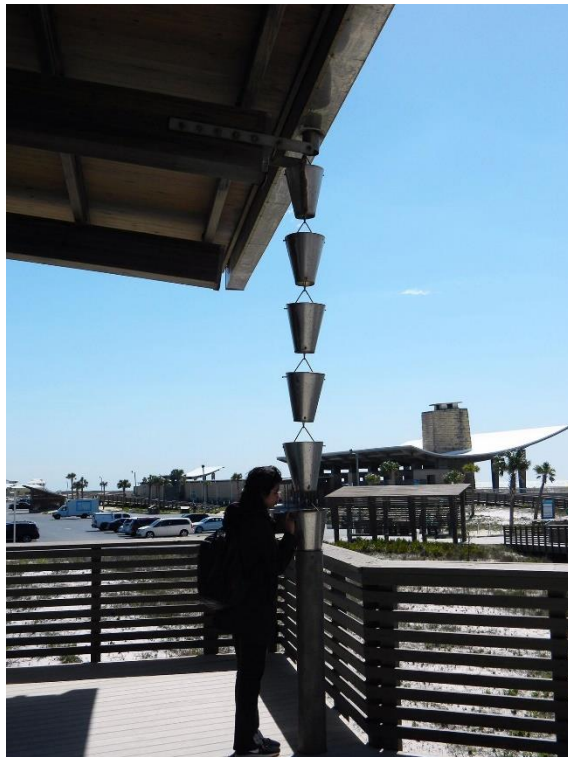
Figure 5. Decorative rain chains help direct rainwater into the cistern (LeBleu, 2022).

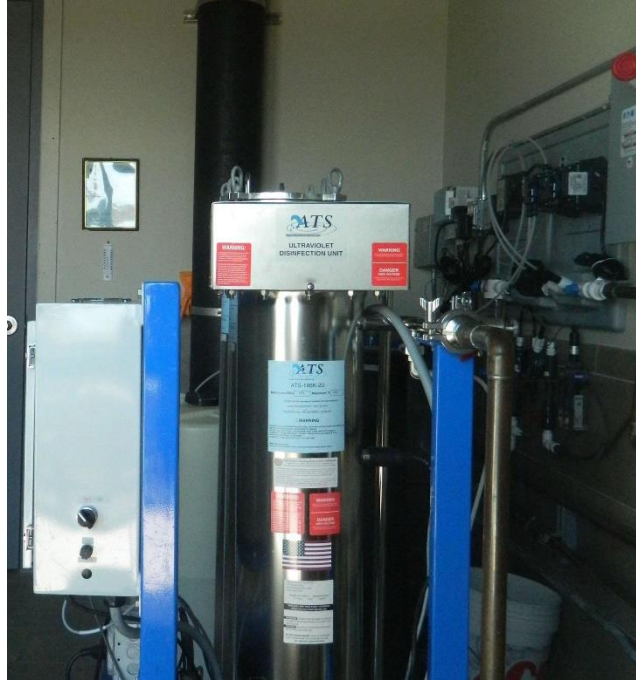
Figure 6. Ultraviolet water disinfection system (LeBleu, 2022).

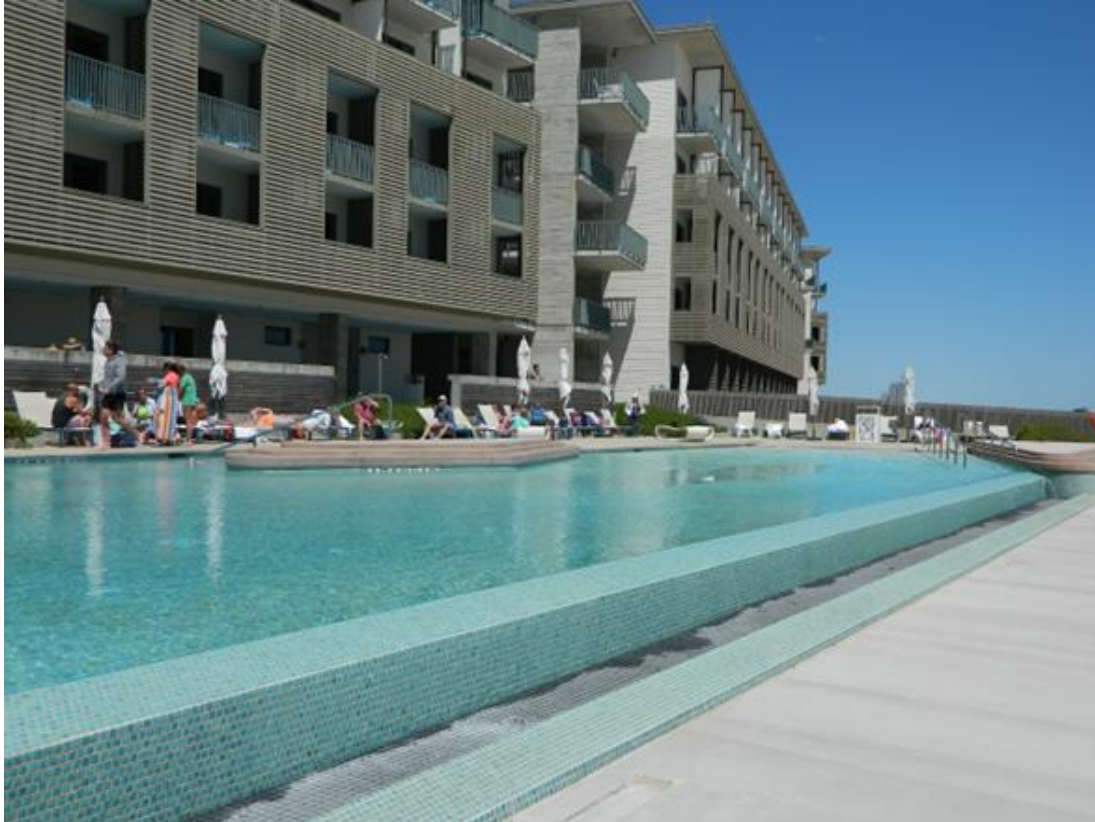
Figure 7. The condensation recovery system at the Lodge provides water for the pool. The system recovers enough water to fill the pool four times yearly (Sasaki, 2018).

The Lodge removes more than 650 gallons per guest room annually (353 rooms) using a condensation recovery system enough to fill the pool 4 times annually (Figure 7).

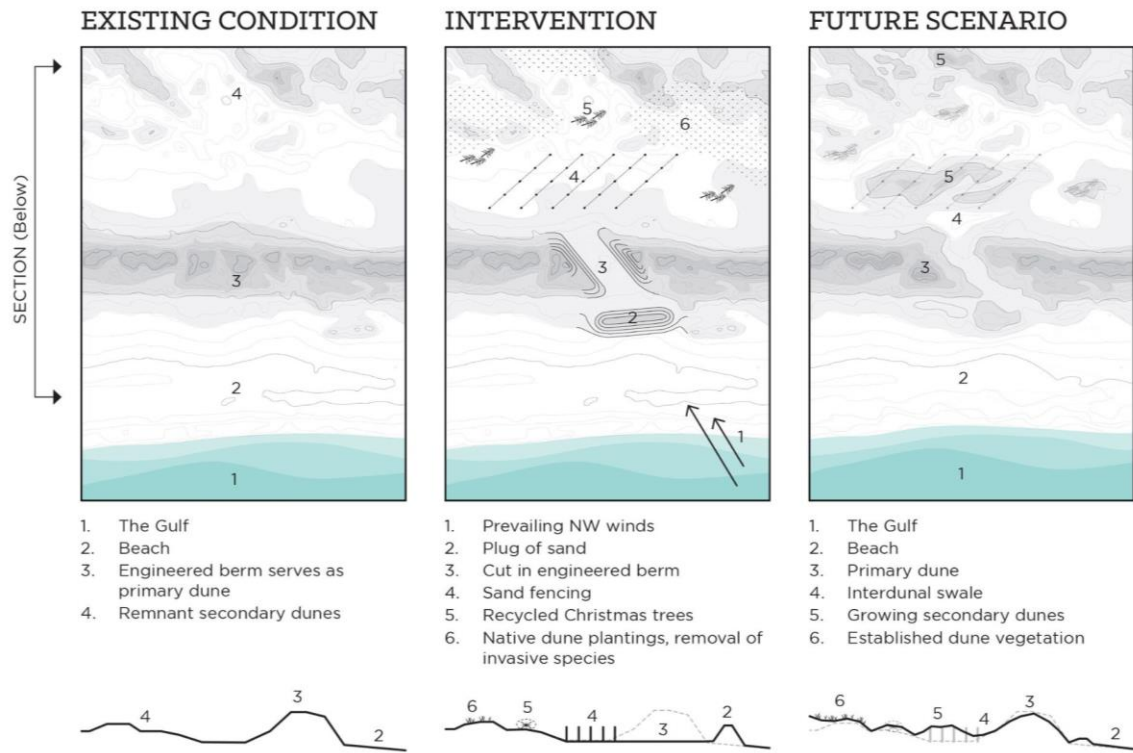
Figure 9. Dune restoration diagram. (Sasaki, 2016).

The extensive dune restoration program implemented innovative strategies to grow a healthy, dynamic, and protective dune system for the park and community. Approximately 15 acres (6.1 ha) of dune were restored to a healthy, dynamic, and complete dune system. This included the creation of cuts through the engineered primary dune, an artificial dune form built of sand brought in from an external source and shaped into a dune using bulldozers and geotextiles. The cuts were strategically created to facilitate sand movement and encourage the growth of secondary and tertiary dunes (Figure 9). Restoration also included plantings of sea oats (*Uniola paniculata*) and saltgrass (*Distichlis spicata*).

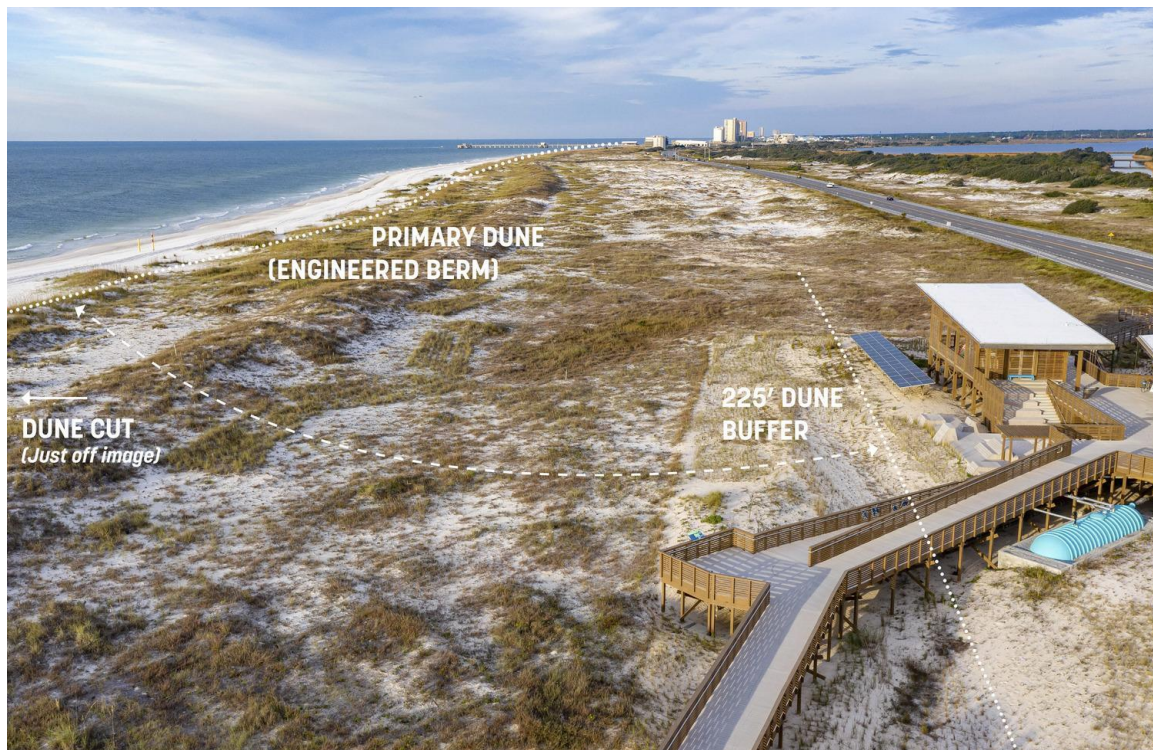
Figure 10. Dune buffer and restoration improves resilience (Sasaki, 2018).

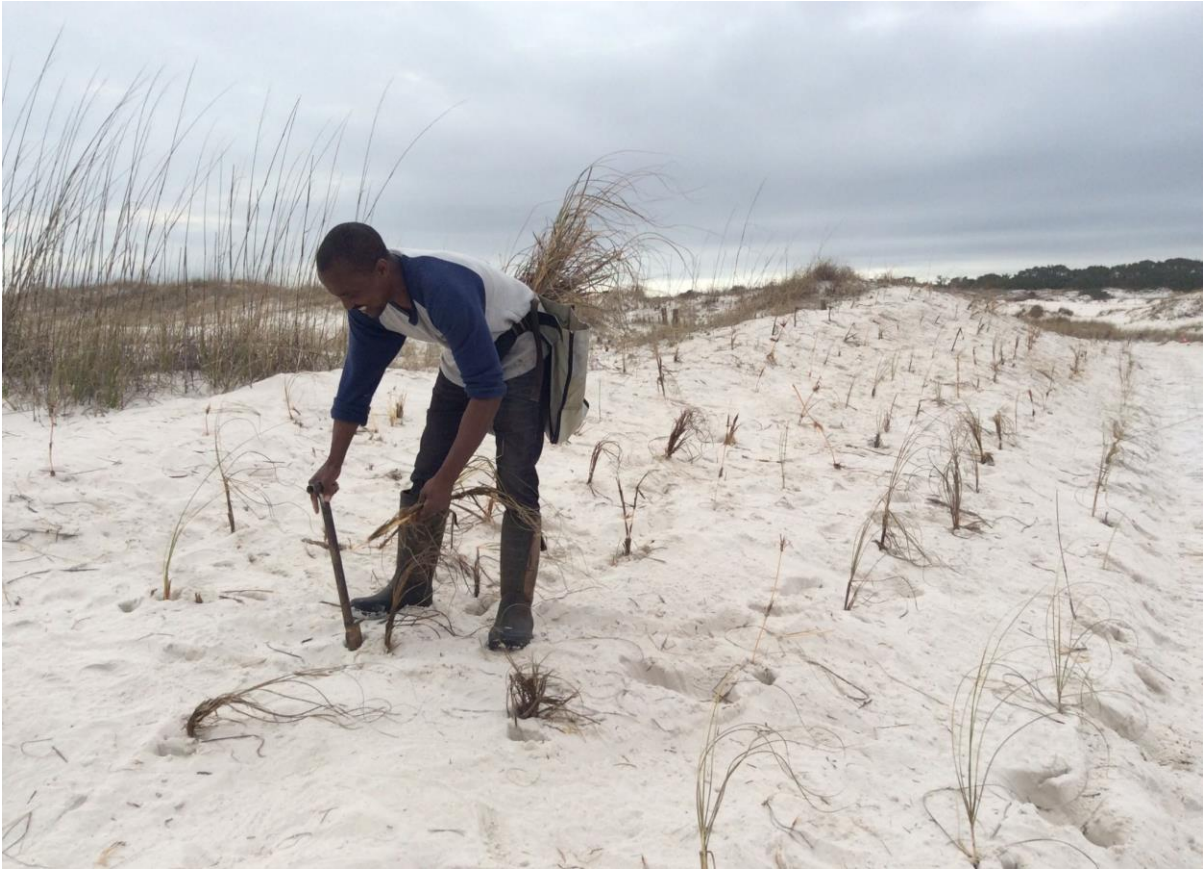
Figure 11. Planting sea oats and salt grass for dune stabilization and habitat (Sasaki, 2016).

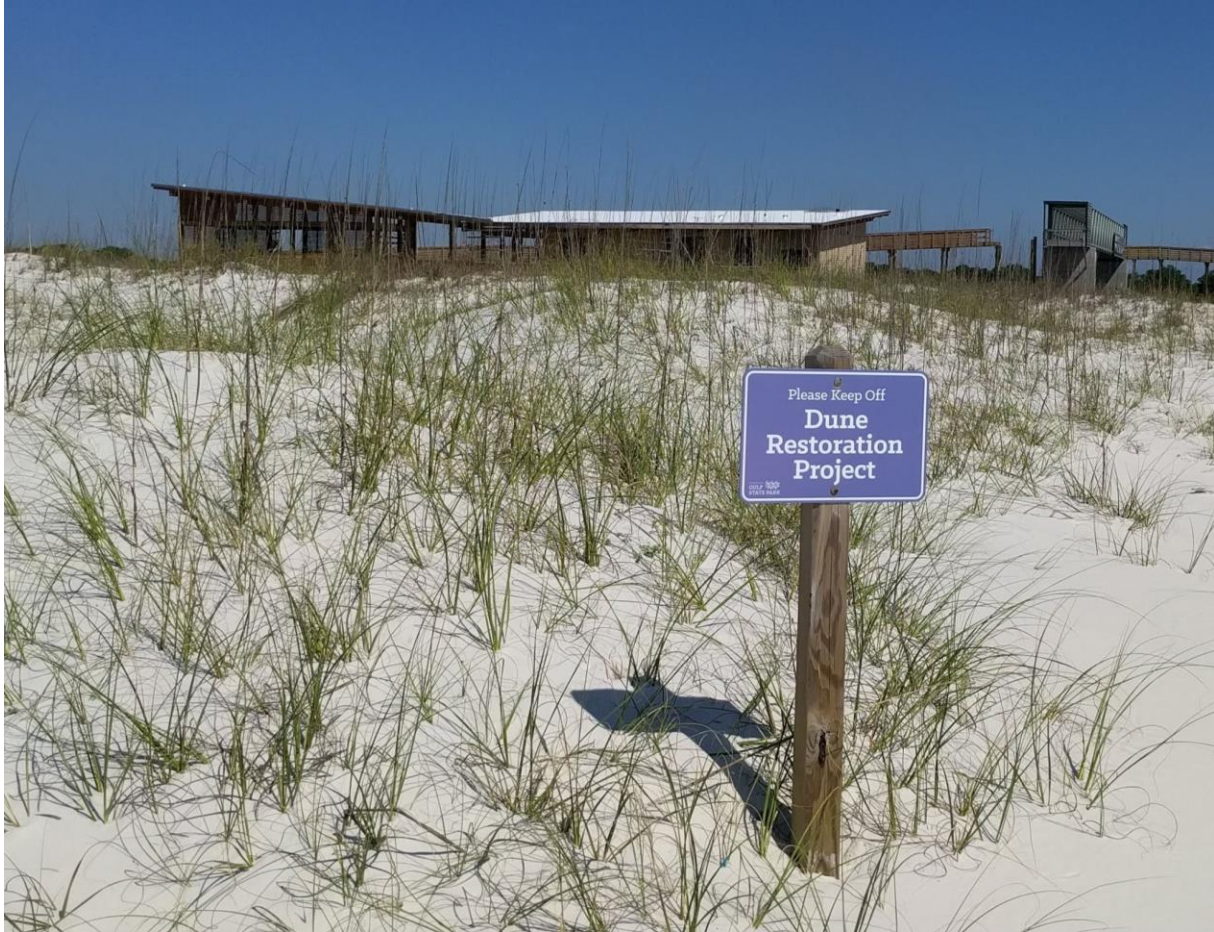
Figure 12. Dune restoration area near The Interpretive Center at GSP (Sasaki, 2018).

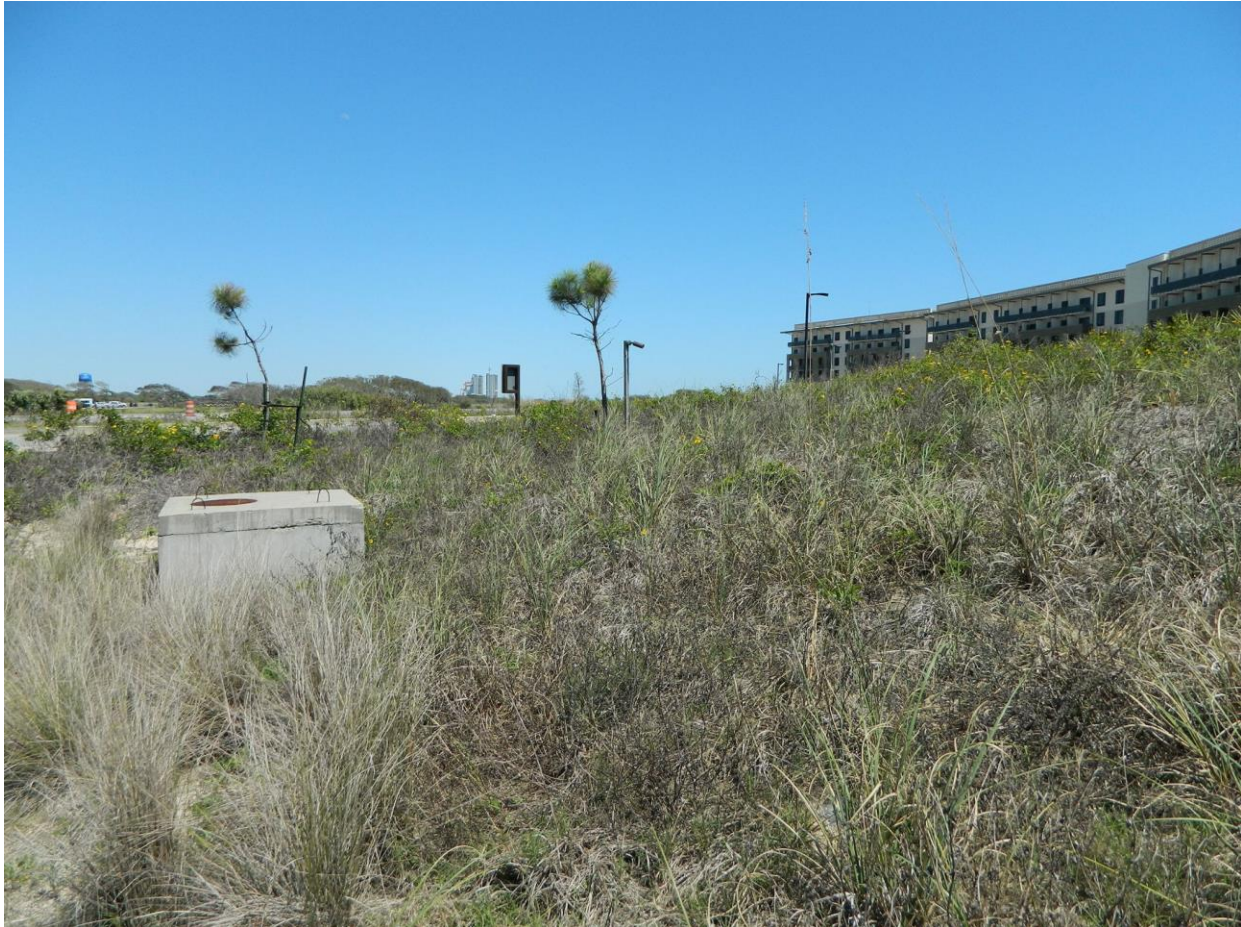
Figure 13. Bioretention at The Lodge at Gulf State Park (Bosu, 2022).

The bioretention area at The Lodge captures and purifies over 1 acre (0.4+ hectares) of stormwater runoff from the adjacent road, parking, and other areas (Figure 13).

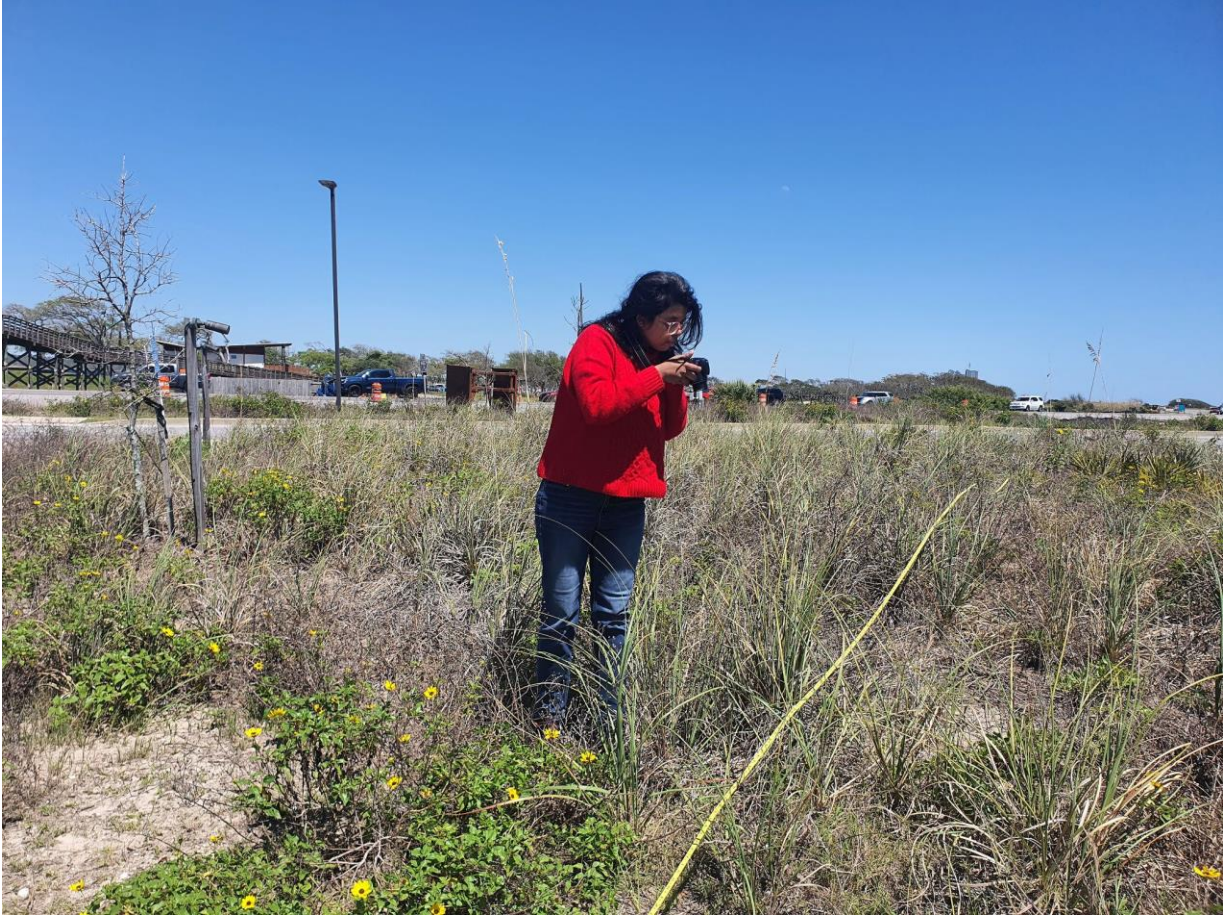
Fieldwork took place in the spring season (April 2022) at The Lodge on the grounds of Gulf State Park. Six 50 ft. (15.2 m) transects were measured using a 100 ft (30.5 m) reel-type steel measuring tape. The starting point of the first transect was chosen based on the perceived typicalness of the plant community within the bioretention and a random toss of the measuring tape (Walker & Menaut, 1991). Each proceeding transect was located parallel to the last and 10 ft apart. Plant species and area coverage were identified along the six 50-ft (15.2 m) transects. Transect lines were photographed for future reference (Figures 15 & 16).

Figure 15. Kangkhita Aishwarya Bosu photographing vegetation along a transect line (LeBleu, 2022).

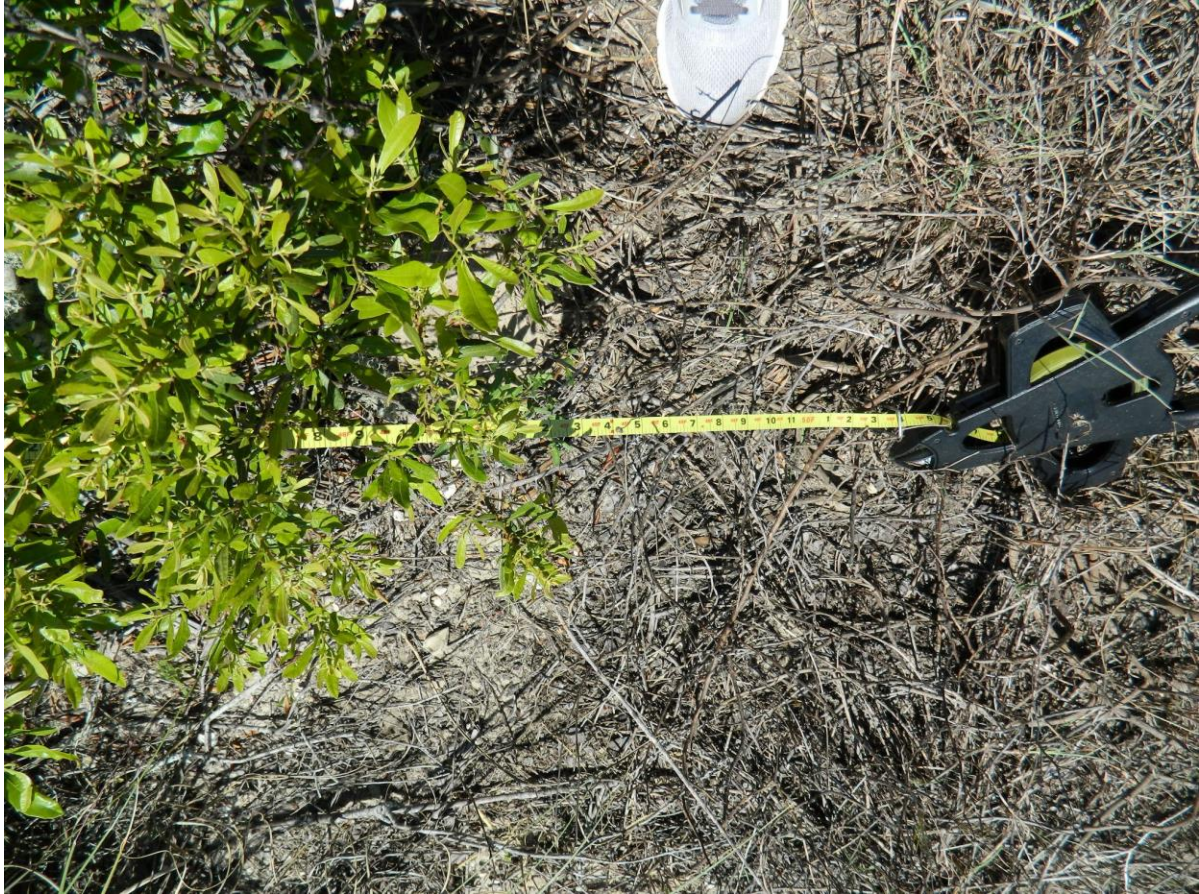
Figure 16. Transect line crossing woody goldenrod, *Chrysoma pauciflosculosa*, in bioretention area (Bosu, 2022).

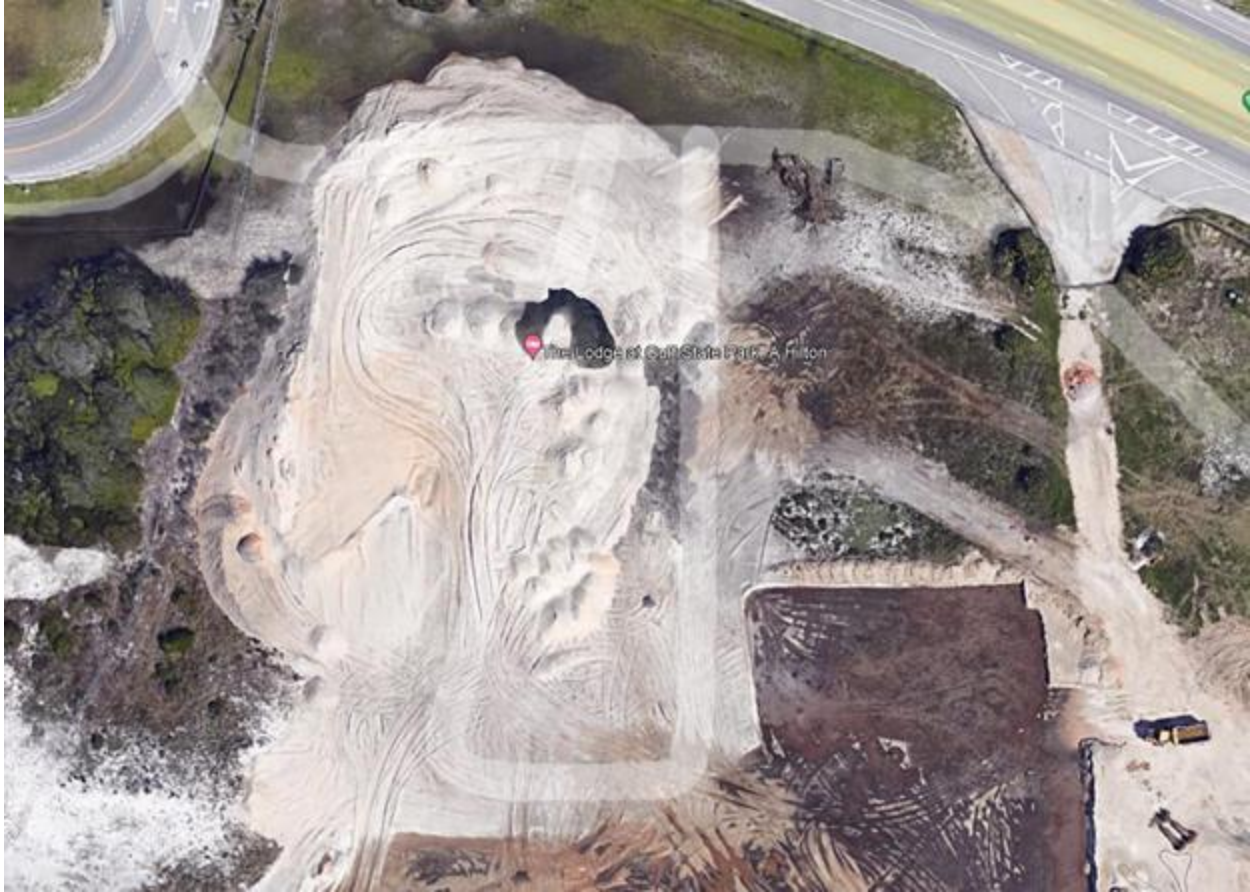
Previously, the bioretention area was part of the old lodge site that Hurricane Ivan destroyed in 2004. The remains of the old lodge were demolished in 2007, making the site essentially a brownfield. Pre-existing plant species were not officially documented, but a 1985 Google Earth photograph of the pre-existing site shows it to be mostly bare sand (Figure 17).

Figure 17. Brownfield site of the demolished old lodge at Gulf State Park, Gulf Shores, AL (Google Earth, 1985).

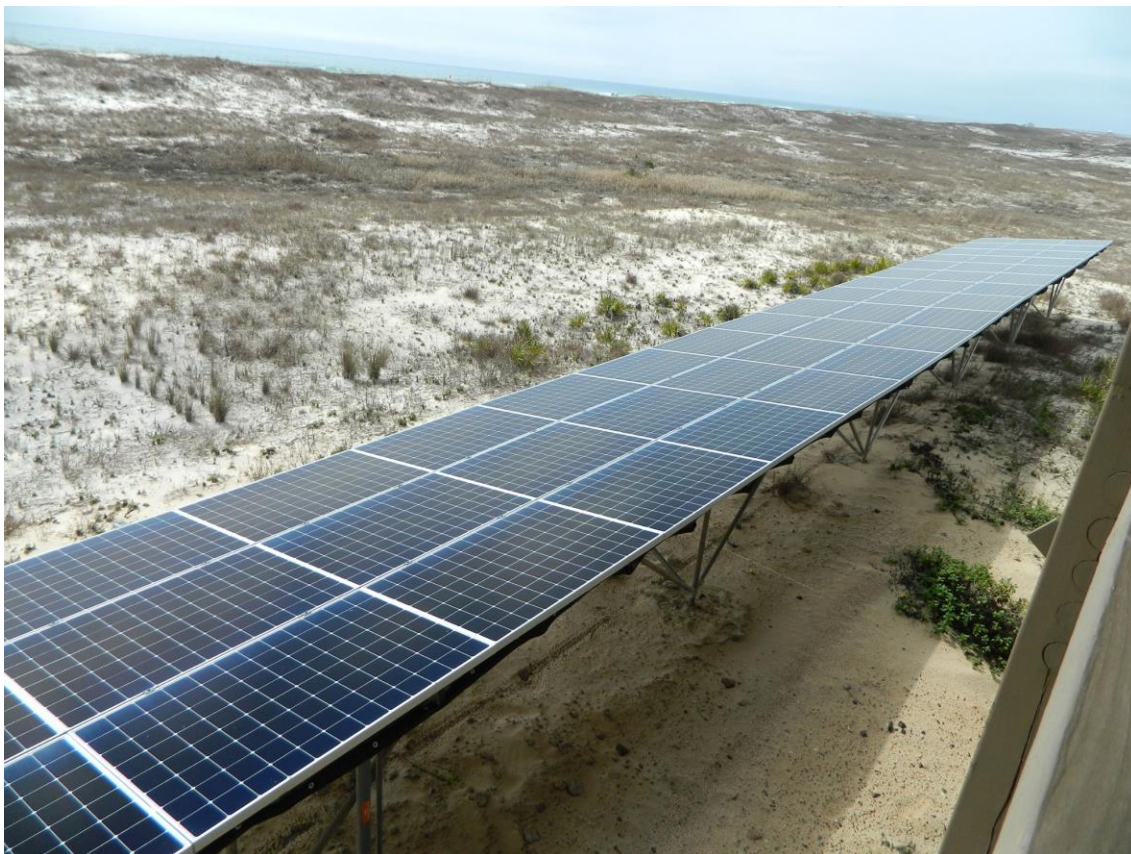
Figure 18. Solar panels are used to power the Interpretive Center (LeBleu, 2022).

The Interpretive Center at GSP is a gateway to the park and introduces visitors to the environment. The Center was designed for net-positive energy, water, and carbon. The 7,500-sf (696.8 sqm) facility is located at the GSP Beach Pavilion and produces its electricity using a 1.48-kW solar array (51 solar panels) installed upon the Center’s completion in 2018 (Figure 18). Solar system production, weather, carbon dioxide emissions avoided, and consumption are continuously monitored online using apps SolarEdge and Green Hub (Figure 19).

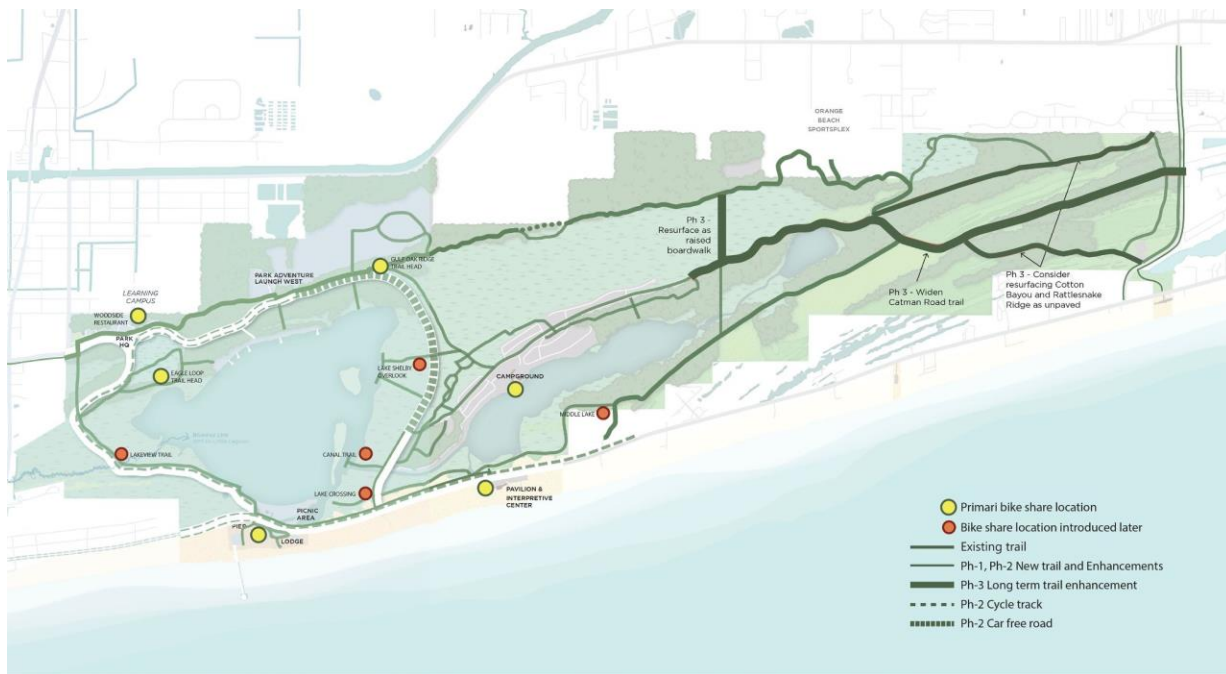
There are 5 bike rental locations: The Lodge at Gulf State Park, Woodside Restaurant, the Interpretive Center/ Beach Pavilion, Eagles Loop Trailhead, and Gulf Oak Ridge Trailhead. As shown on the map, some new locations have also been added recently (Figure 28). Bikes can be returned to any of the designated bike parking areas; however, they do not have to be returned to the same locations where they were checked out.

Figure 28. Bike Share Program locations map (Sasaki, 2016; Bosu, 2022).

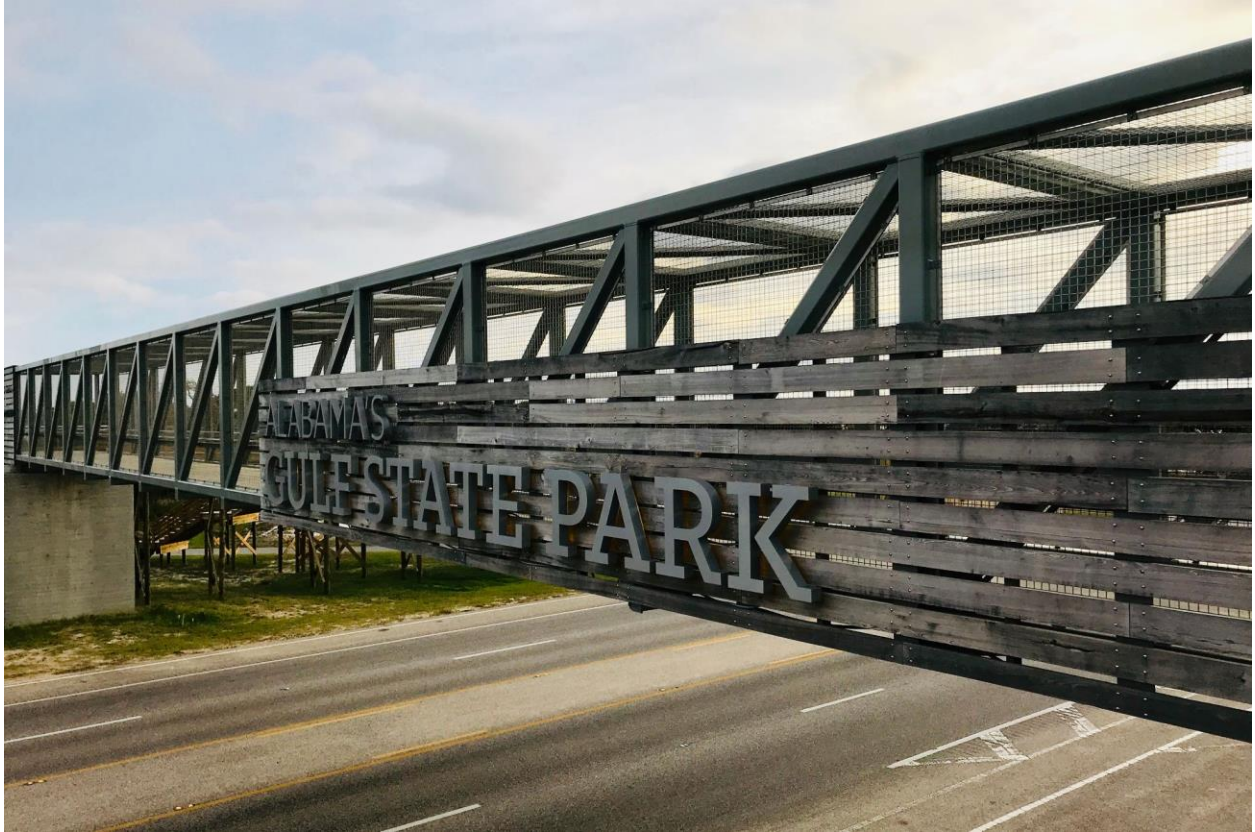
Visitors enjoying the bike trails can easily travel throughout the park interior and beachside using one of the two bridges over Beach Blvd. located at the east and west ends of the park (Figure 30 & 31).

Figure 30. The bridge at the west end of the park near The Lodge (Sasaki, 2018).

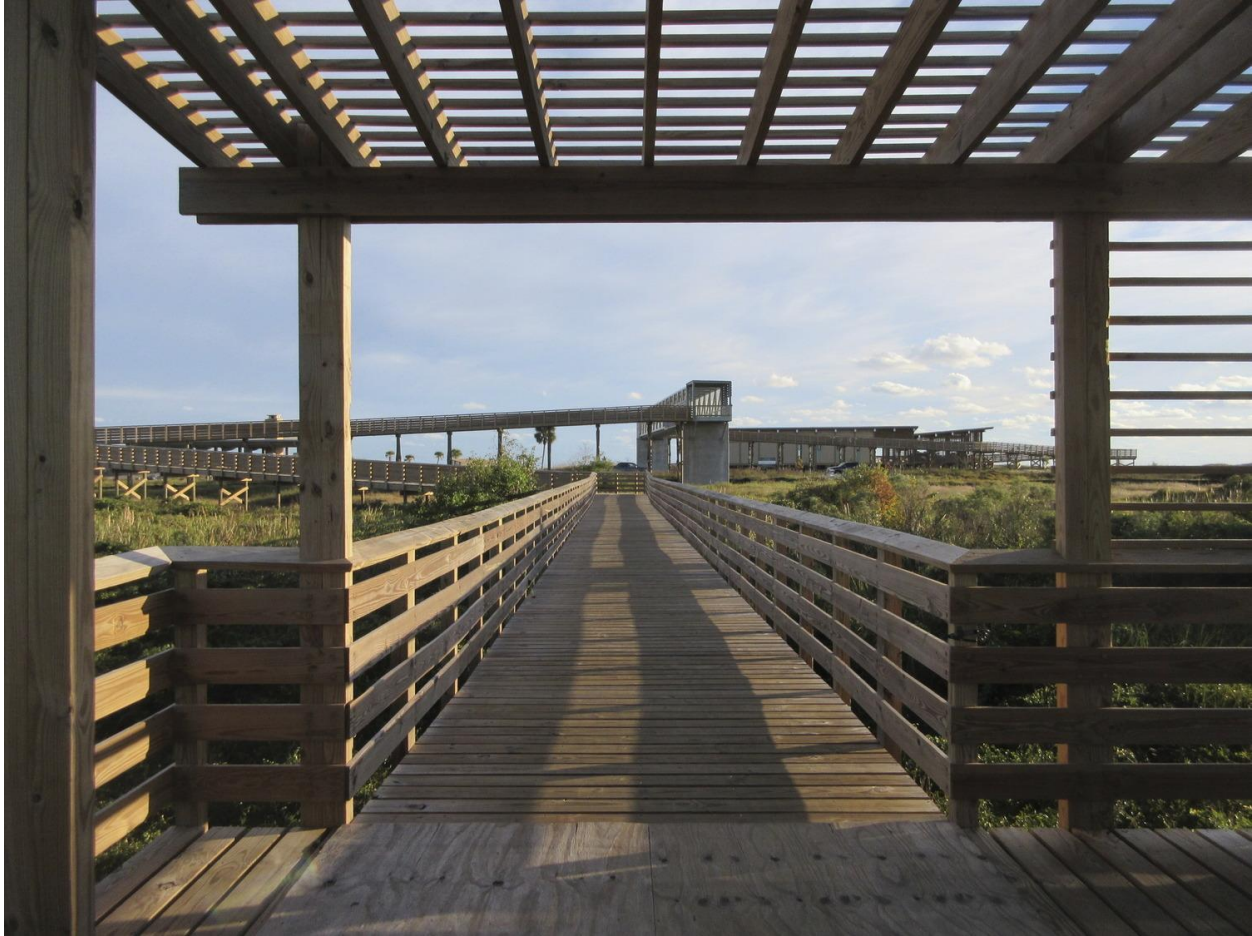
Figure 31. The bridge at the west end of the park showing ramps (Sasaki, 2018).

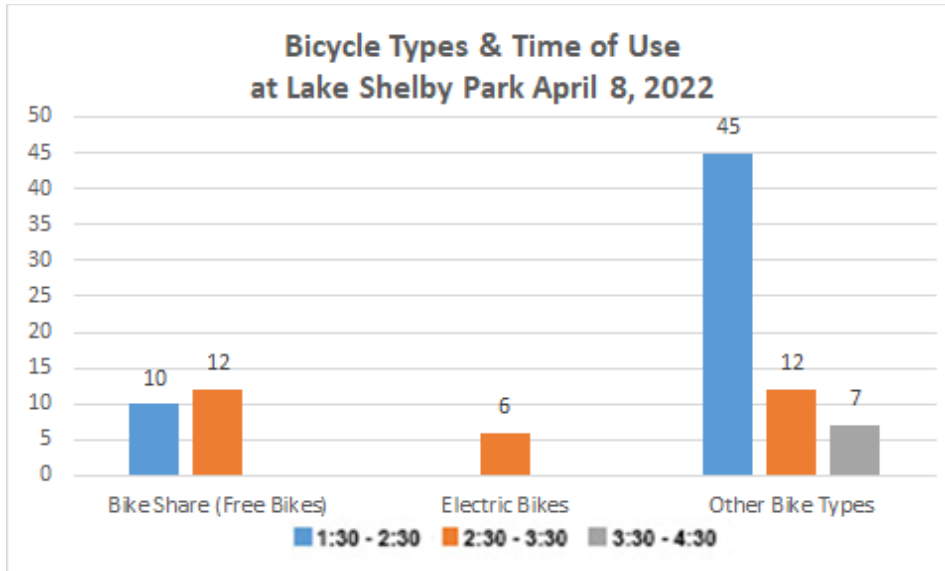
Figure 33. Bicycle Types and Time of Use at Lake Shelby Park April 8, 2022 (LeBleu, 2022).

Most of the bicycles observed were *other bike types* (64), with most of these seen between 1:30 pm to 2:30 pm. 22 GSP Bike Share Program (free) bikes were observed from 1:30 pm to 3:30

pm. An additional six electric bikes were observed between 2:30 and 3:30 pm (Figure 33).

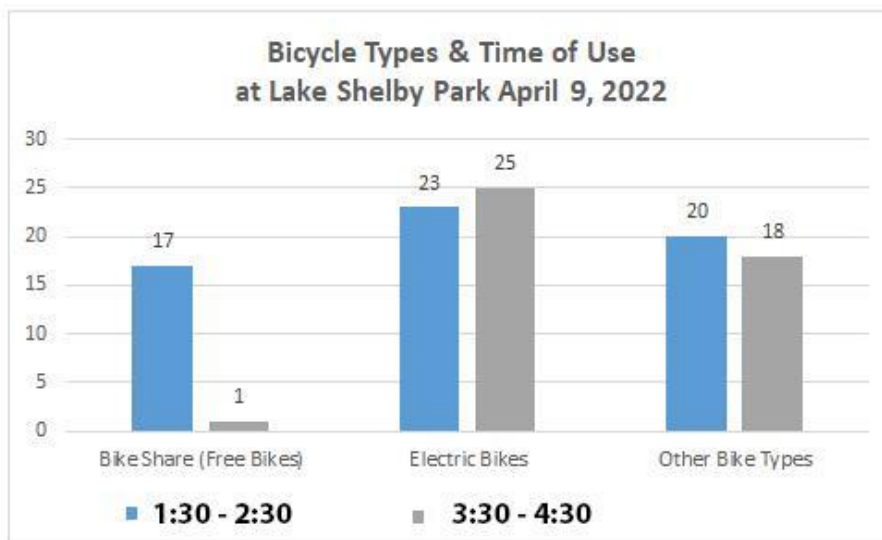
Figure 34. Bicycle Types and Time of Use at Lake Shelby Park April 9, 2022 (LeBleu, 2022).

Most of the bicycles observed were *Electric Bikes* (48), and the numbers were about equally split between 1:30 - 2:30 pm (23) and 3:30 - 4:30 pm (25). 18 GSP Bike Share Program (free) bikes were observed from 1:30 pm to 4:30 pm with the majority seen from 1:30 - 2:30 pm (17). An additional 38 Other Bike Types were observed from 1:30 pm to 4:30 pm (Figure 34).

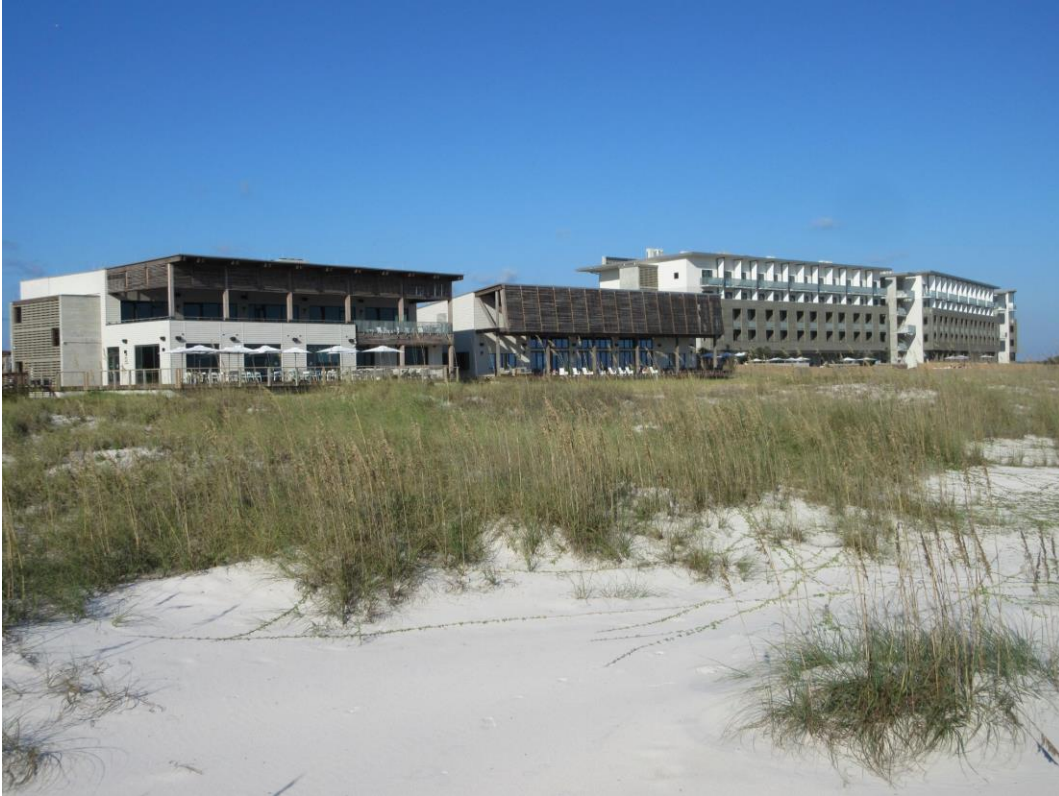
Figure 35. The Gulf Shores State Park Lodge was built with a FORTIFIED roof (Sasaki, 2018).

The FORTIFIED design required more fasteners, more adhesive, and more labor. On top of the increased safety factor, the roof was subject to at least two inspections by certification engineers that flew in from Miami (Figure 35).
