## STLCC Forest Park Center for Nursing and Advanced Health Sciences Methods

This investigation was conducted as part of the Landscape Architecture Foundation's 2022 *Case Study Investigation* (CSI) program. CSI matches faculty-student research teams with design practitioners to document the benefits of exemplary high-performing landscape projects. Teams develop methods to quantify environmental, social, and economic benefits and produce Case Study Briefs for LAF's *Landscape Performance Series*.

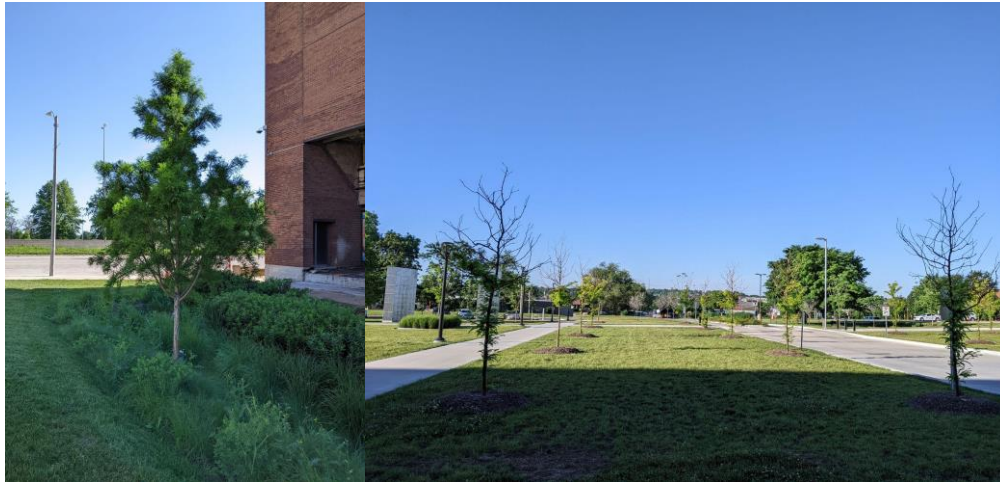
Figure 2. Comparison of tree conditions

(On the right: healthy tree with gator bag located in between buildings; on the left: wilted trees without gator bags in the open area)

- During field visits, we found that most of the trees on the site did not have slow-release watering devices installed, a deviation from the contract documents. The absence of these slow-release devices (gator bags) could be another cause of tree distress. Trees with slow-release watering devices differed in their overall health condition, as they appeared greener and fuller. The amount of sunlight may contribute to better health

outcomes for the trees as well. We observed the healthy trees in locations of less direct sunlight with slow-release devices and reasonably concluded these conditions contributed significantly to their overall well-being (See Figure 2); however, this conclusion needs more testing and observation to understand the actual reasons.

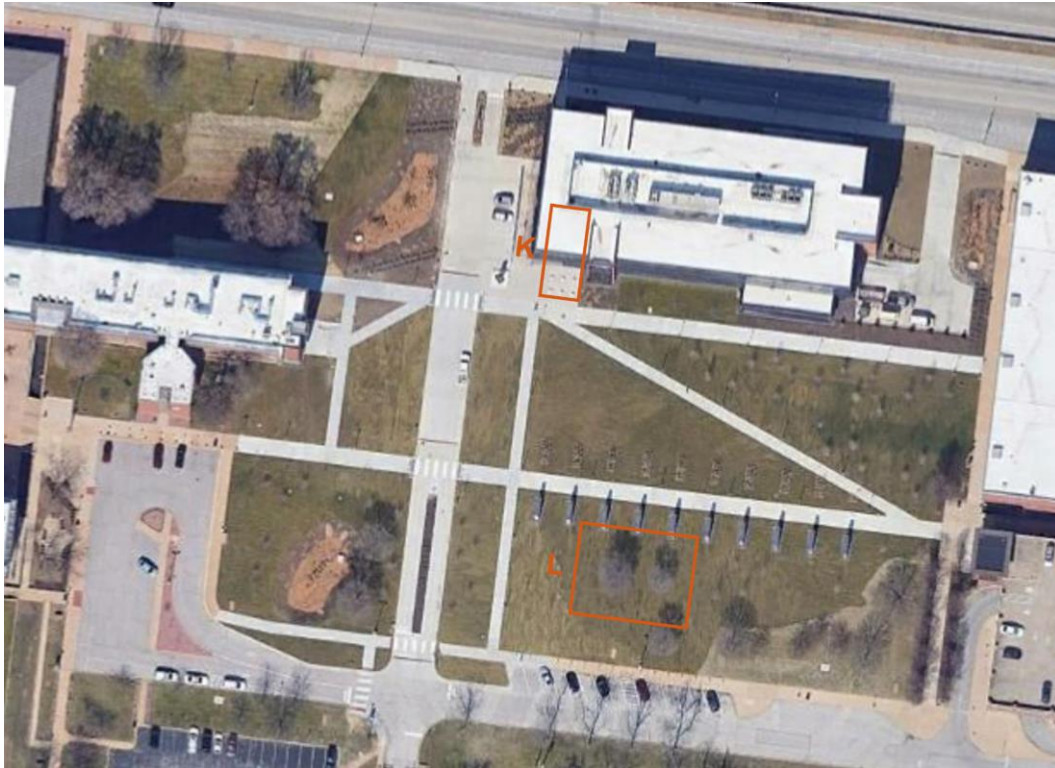
Figure 4. Locations of the observed static behaviors

Outcomes of the observations fit the expectation of where people stay on the campus – the sitting area with cover and movable furniture next to the building entrance. Table 2 shows that we observed five groups staying at the sitting area (area K in Figure 4) and one sitting on the lawn (area L in Figure 4) for a short period (10 - 90 minutes). Five of the groups had only one person and a group of six people. People used the area for working, gathering, dining, and waiting. Most users came to have lunch during noon.

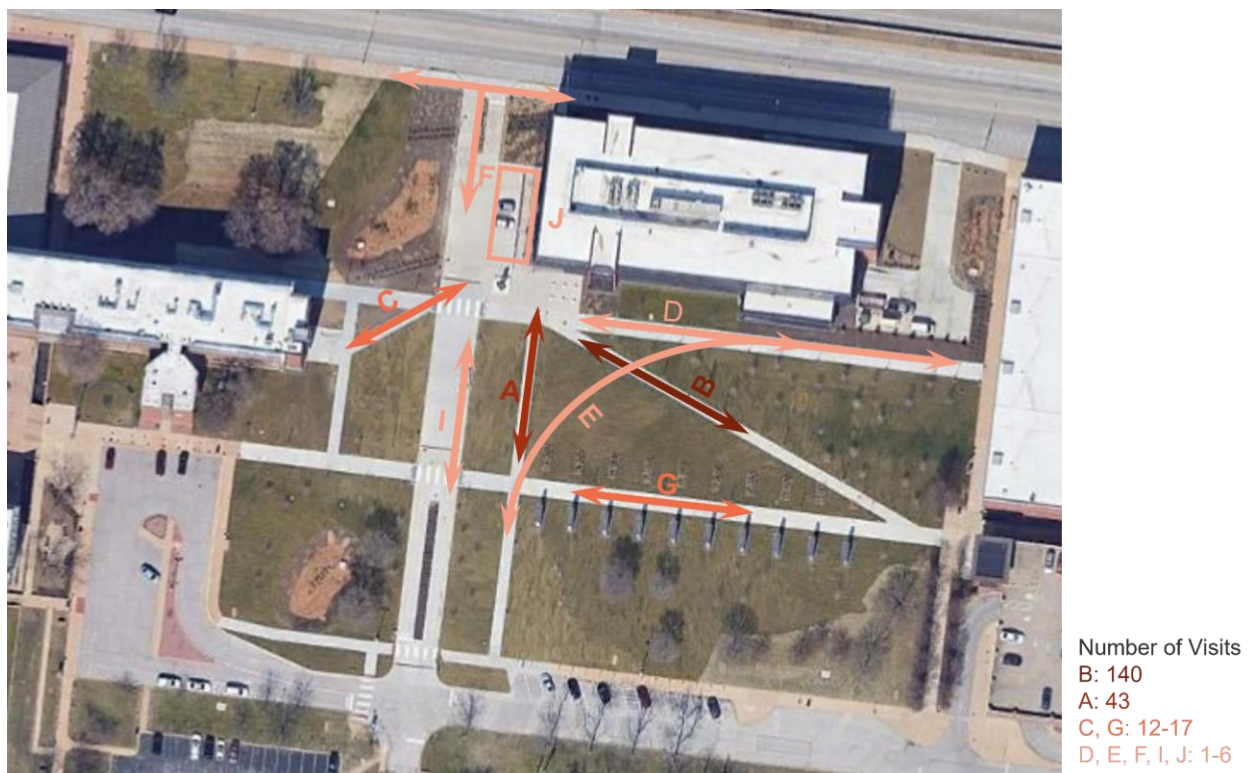
Figure 6. Routes of pedestrian movement by observation

The thickness of the arrows demonstrate the frequency of the usage, the thicker, the more frequent visits observed. The frequency is categorized into four levels based on the visit counts.

We conducted observations on two weekdays during the summer term (the detailed observation time is shown in the method section of the occupancy benefit). Pedestrians arrived during the times between classes, which were in the morning (between 7:00 and 8:00 am) and at noon (between 11:30 am and 12:30 pm). Many of them were those attending classes in the new building. There are generally, however, fewer people around the campus during the summer term, according to the District Division Dean of Health Sciences, Dr. Hubble. The results of the observations are summarized in Figure 6 and the details are shown in Table A1 (Appendix).

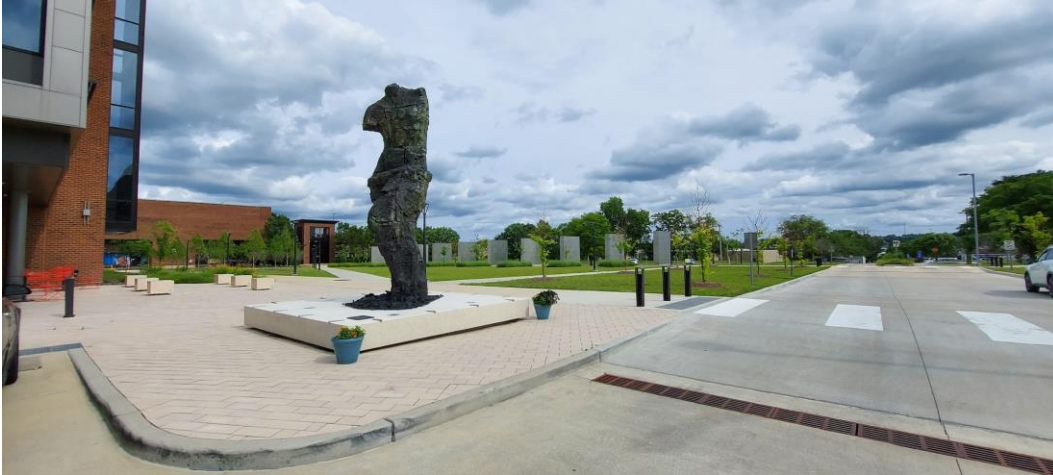
Figure 7. The entry driveway (on the right) runs through the campus and the main entrance.

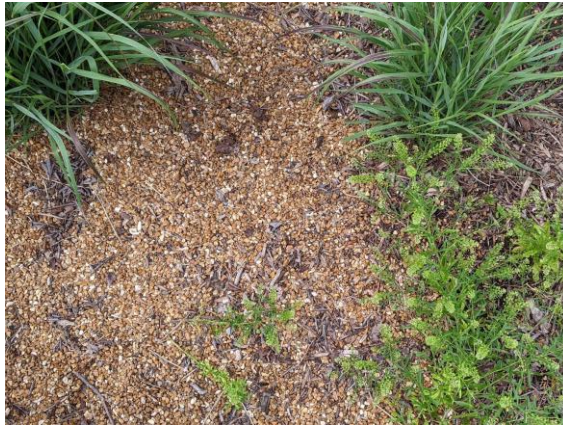
Fig 10. The 3/8" Meramec gravel cover in the bioretention garden area.

The renovated landscape has a more densely planted area; however, we measured a rather higher temperature on the 3/8" Meramec gravel cover inside the bioretention area (Figure 10). We had two points measuring this material, the temperature was 84.2 °F and 87.9°F. The temperature was slightly lower than but almost the same as the average pavement surface temperature, 87.7 °F. As a result, the average temperature of the densely planted area increased. This layer, the Meramec gravel, is required by St. Louis City code. Although reducing temperature is not the primary goal of implementing bioretention gardens, it is a point that can be improved to create a comfortable environment.
