# LANDSCAPE PERFORMANCE SERIES

## Cascade Garden – Aspen, CO Methodology for Landscape Performance Benefits

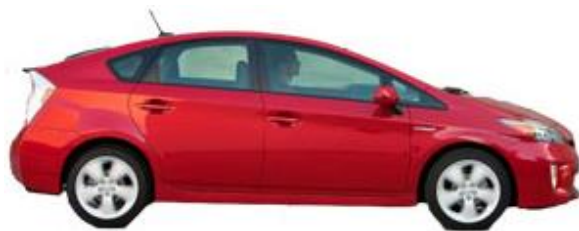
**Figure 4.** Color Overlay matching the Prius' outline

The photograph was imported into Adobe Photoshop where a color overlay was applied to give the car a solid color. The image was flipped vertically to match the direction of travel of the Prius in the panoramic photo (Figure 4). The image was resized in Photoshop to match the scale of the car as it appears in the photograph. The image of the car was then copied and pasted repeatedly to create a swath from one end of the property to the other that is representative of the total area the vehicle would occupy when traveling on the road (Figure 5). This is the visual area that would

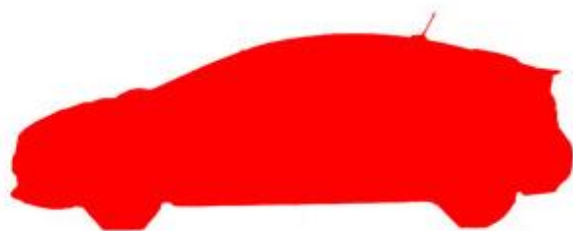
**Figure 5.** The line of travel swath layered atop the panoramic photograph

The histogram feature in Photoshop was used to measure the number of pixels present in the swath layer (Figure 6). This is the number of pixels that would be visible if no buffer were present.

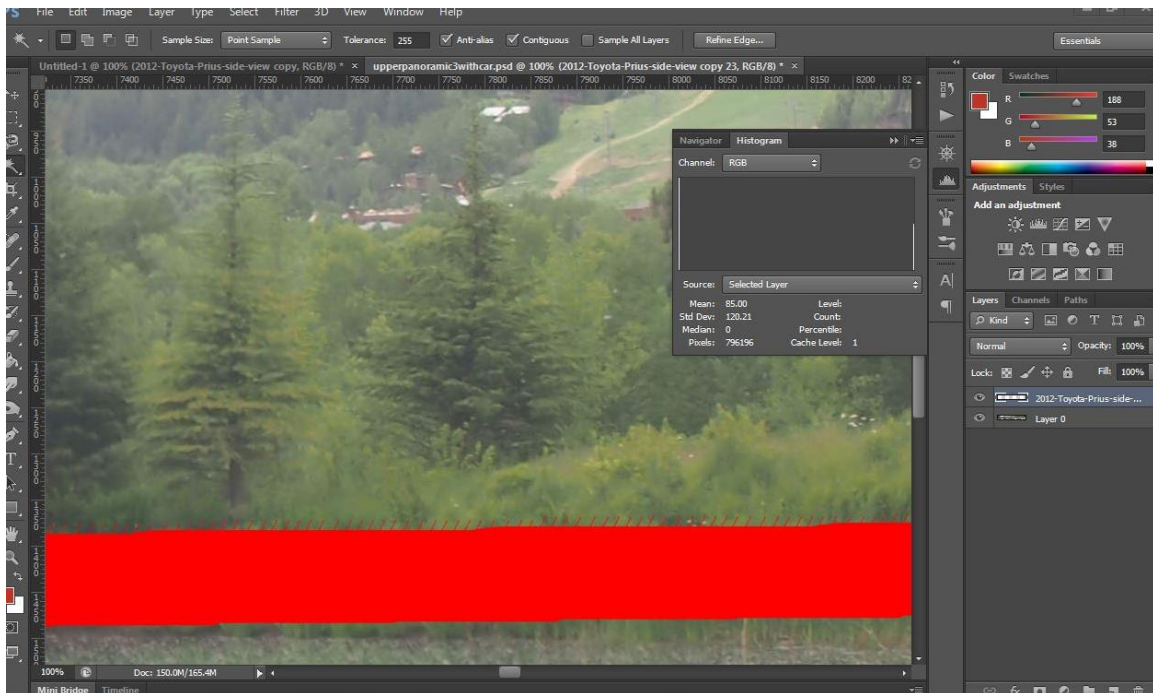
**Figure 6.** Pixel count for the selected layer (the traffic swath)

There are a total of 796,196 pixels in the swath. Note that the Cache Level on the Histogram has been set to 1 to ensure that the entire layer is being evaluated, not a random selection (to save time Photoshop will often survey a random selection of pixels to create the histogram, thus limiting the count to  $\frac{1}{4}$  or  $\frac{1}{2}$  the actual number present).

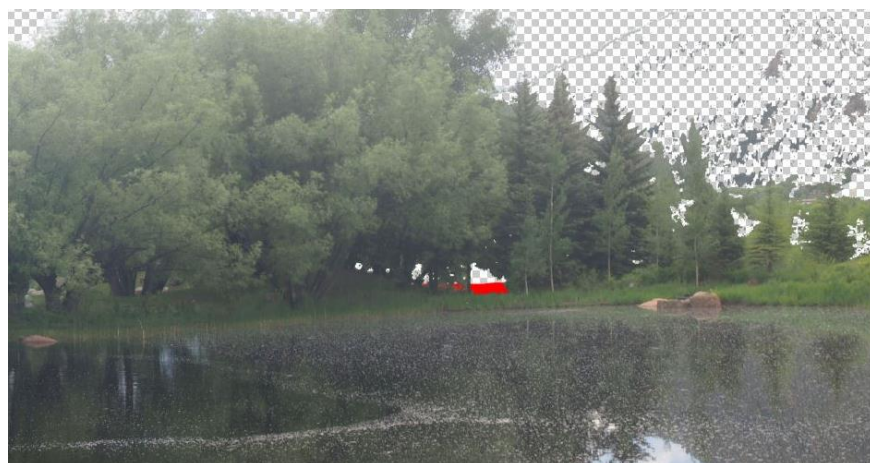
**Figure 7.** Removing the background revealed the visible parts of the traffic swath.

The swath layer was moved underneath the panorama layer and the wand tool, set on a very low tolerance, was used to erase those parts of the panorama image that lie on the far side of the road (Figure 7). This revealed the swath in just those areas that are not covered by berms, plantings, fences, or gates on the property.
