Meadow Creek Stream Restoration¹
Methodology for Landscape Performance
Benefits
Case Study Investigation 2014
University of Virginia

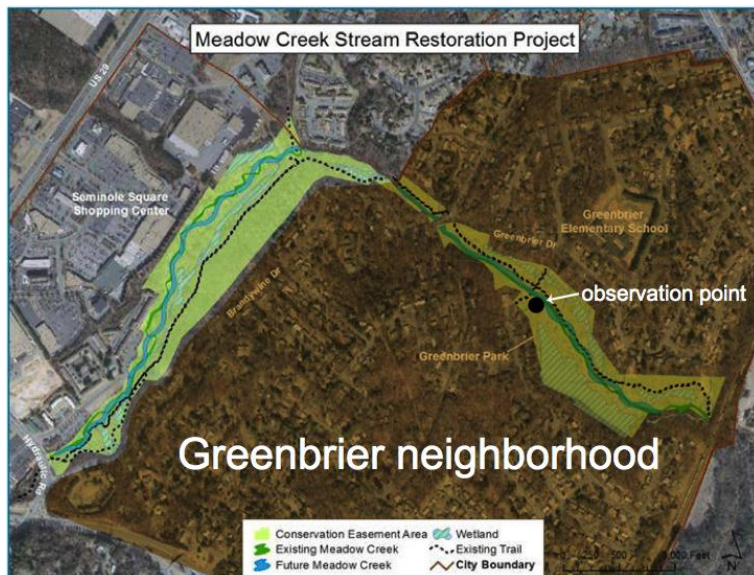
Figure 12. Aerial view of Meadow Creek showing the researcher's observation point at the bridge that connects the Greenbrier neighborhood across Meadow Creek

Method: To measure site use, the research team conducted site observations and a neighborhood survey. During the team's site visit to Meadow Creek, a visitor traffic count was conducted (counted all users for 3 2-hour periods between 8am-8pm, once in the morning, once mid-day and once in the evening) and an activity mapping (types of activities and locations observed by the researchers) following Jan Gehl's PSPL survey method. The observations took place on Saturday June 14, 2014; the weather was mild, a high of 83°F and sunny. The research team dispersed the Stream Restoration & Resident Use survey through the neighborhood email listserv, which provided residents with a link to an online survey (surveyplanet.com). They were given 2 weeks (June 20-July 4) to complete the survey. 47 responses were received and analyzed.

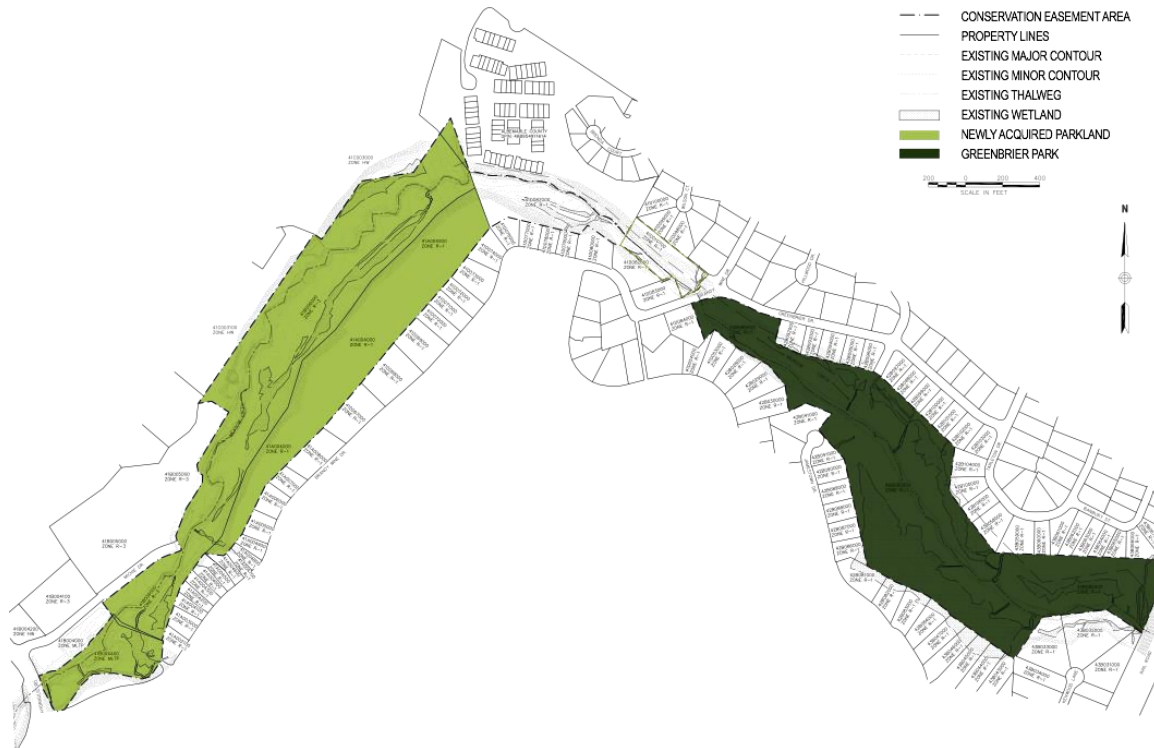
Figure 6. Expansion of parkland along the Meadow Creek restoration

Method: Using land acquisition data from the Nature Conservancy and City of Charlottesville, the acreage of the new parkland was compared to the acreage of the existing Greenbrier Park. Both new and existing parkland are now under a conservation easement to prevent future development and preserve the ecological integrity of the riparian zone. Additionally, this new public green space now provides the residents of the Hearthwood Apartments with passive recreation space along the creek corridor.
