**Renaissance Park
Methodology for Landscape Performance Benefits
Case Study Investigation 2014**

Research Fellow: Brad Collett, ASLA, RLA, LEED AP
Assistant Professor, The University of Tennessee - Knoxville

Landscape Performance Benefits & Methodologies

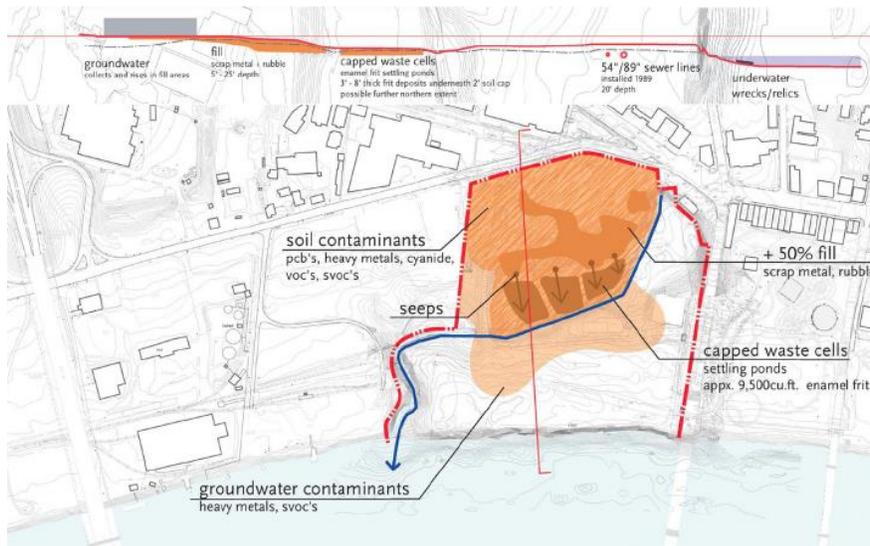
Figure 1. Site Contamination Study. Source: Hargreaves Associates

The site's industrial past as a manufacturing/finishing facility for consumer-grade stoves contaminated soil throughout the site to varying degrees and with a range of toxic contaminants, including PCBs, heavy metals, cyanide, SVOCs and VOCs. The most threatening was 12,000 cubic yards of soil comingled with enamel frit. Capped waste cells where the manufacturer had disposed of this material were leaching contaminants into groundwater resources, creating a contaminated groundwater bloom down gradient from the capped cells.

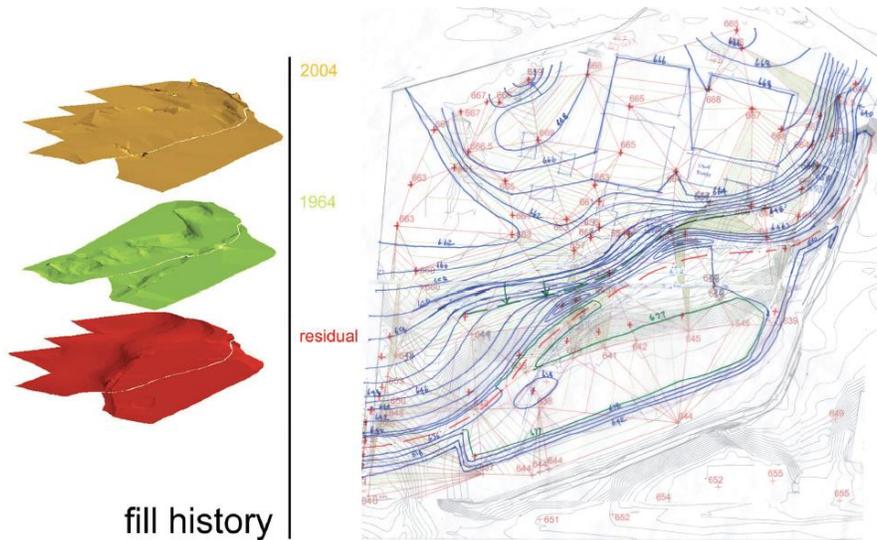
Figure 2. Study of site's historic topography. Source: Hargreaves Associates

A digital topographic analysis of the site was conducted using historical maps of the site's undeveloped and post-industrial conditions, soil borings, and groundwater analysis to generate three-dimensional models of the likely extent of contaminated soil. This analysis allowed the team to design the site and properly size the site's iconic landforms under which contaminated soils were to be encapsulated.

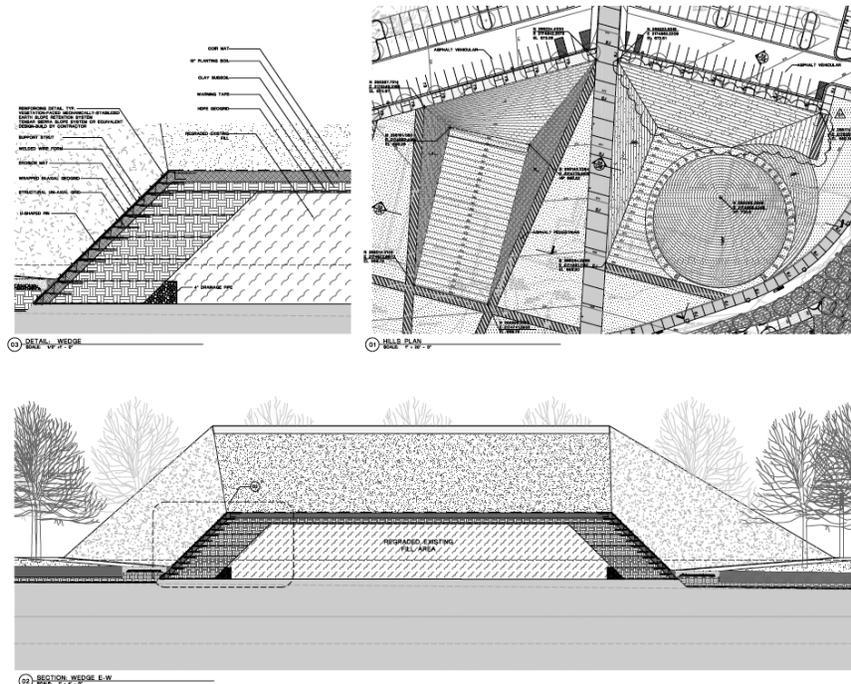
Figure 3. Iconic landforms safely encapsulate regraded contaminated soils. Source: Hargreaves Associates

34,000 cubic yards of contaminated soils were excavated and redistributed to areas of the site that required fill. These areas were designed by the project team to be outside of the 100-year floodplain and safe from groundwater intrusion. Redistributed soils were graded according to plans and safely capped with a complex stabilization and safety assembly that included geogrids, warning tape, and not less than two feet of clay subsoil and planting soil. An underdrain system is installed within the cells to move any leachate from these soils to the sanitary sewer system.

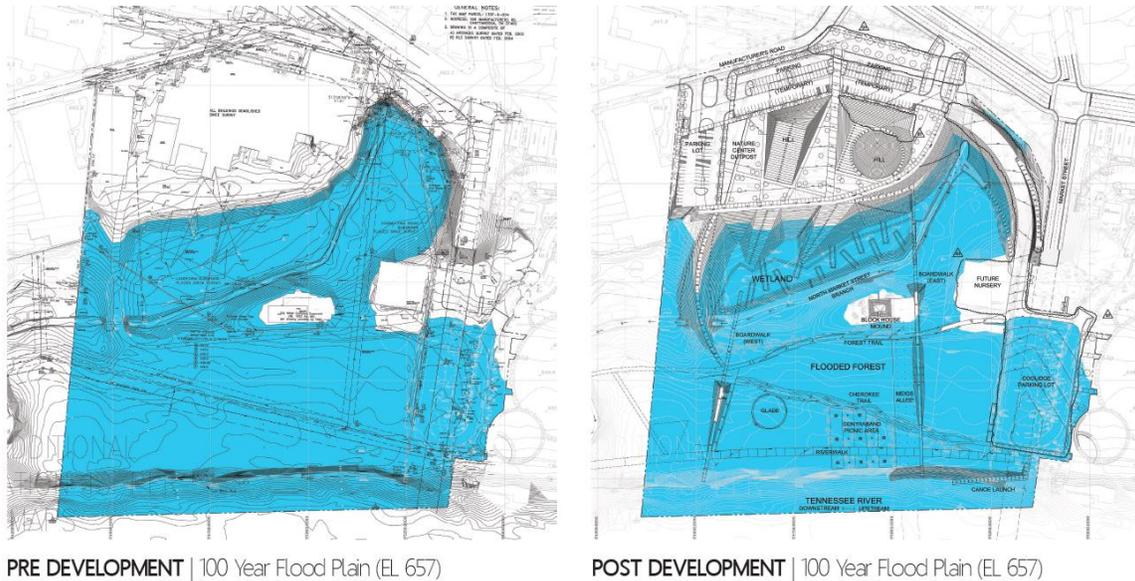
Figure 4. 100 Year Floodplain

The portion of the site where contaminated soils were excavated from capped waste cells of enamel frit was excavated as much as 10' below finished grade. This +/- one acre area is creatively redesigned as a one-acre constructed wetland that receives, retains, and treats runoff from the site while increasing the storage capacity of the 100-year flood by 9.32 acre feet. Though the surface area of the floodplain appears reduced in the above pre development and post development diagrams (Figure 4), the depth of the wetland excavation yields a net increase in floodplain volume.

Per project construction documents, the net total volume of contaminated soils excavated below the 100 year flood elevation is 18,000 cu yd. This figure takes into account the volume of clean fill replaced in the flood plain as part of site improvements and the normal pool level (EL 640) of the constructed wetland that is within the void that once contained contaminated soils.

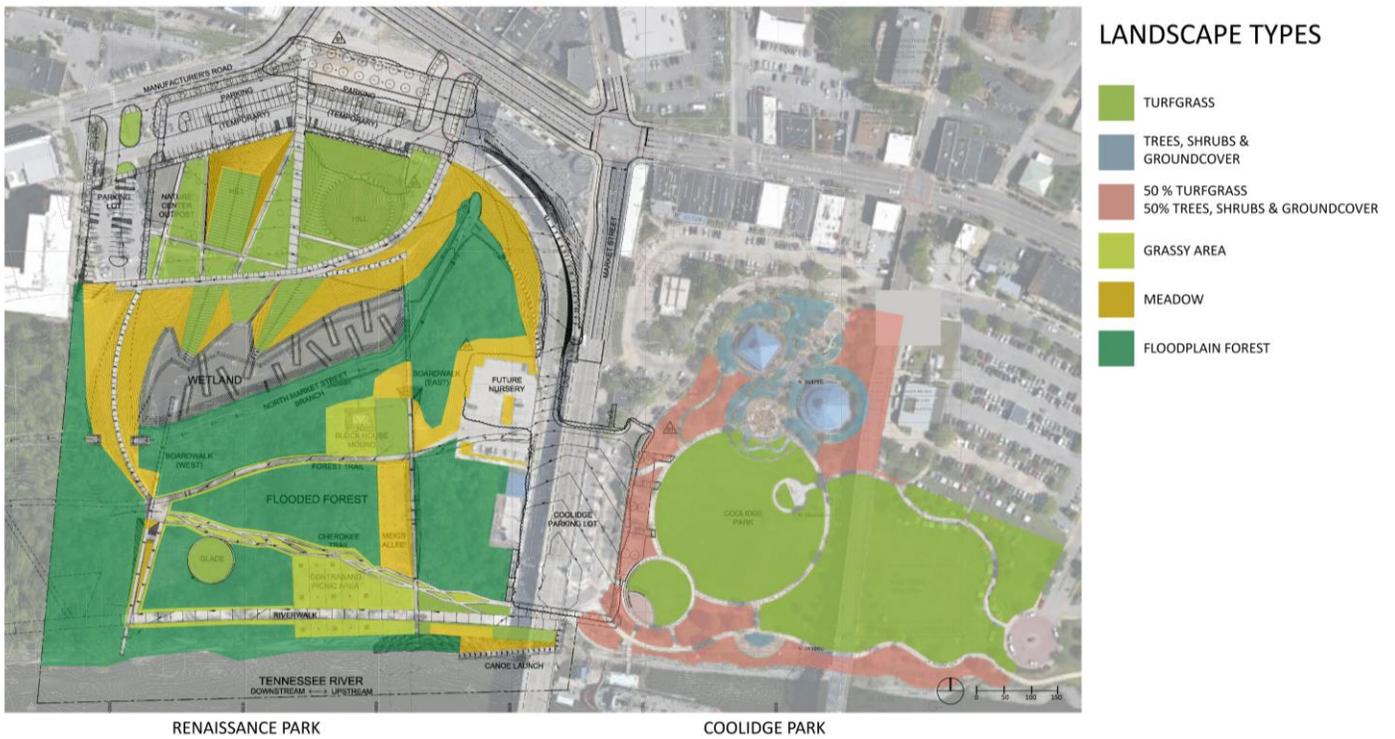
Figure 6

This volume was calculated by the research team by first calculating the average surface area within consecutive contours (640-641, 641-642) and then multiplying average areas (sq ft) by one foot of elevation to determine the volume (cu ft.). Calculations are shown below in Figure 5.

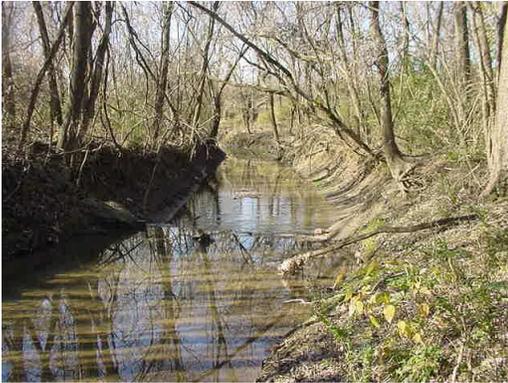
Figure 12 shows the stream in 2002. Notable is the excessive sediment deposition, eroding and incised streambank and lack of riffles. Figure 13 shows the stream in 2014. The streambank shows improved stability and vegetative cover, as well as an improved frequency of riffles and reduction in sediment.

Figure 12. 2004

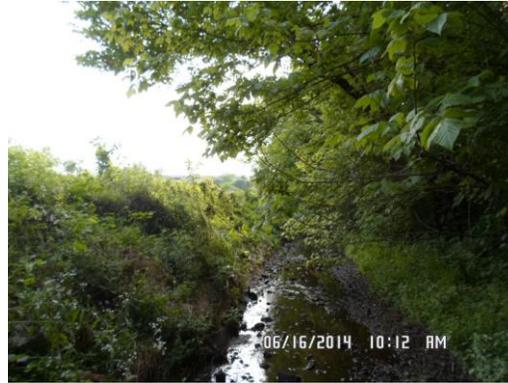
Figure 13. 2014

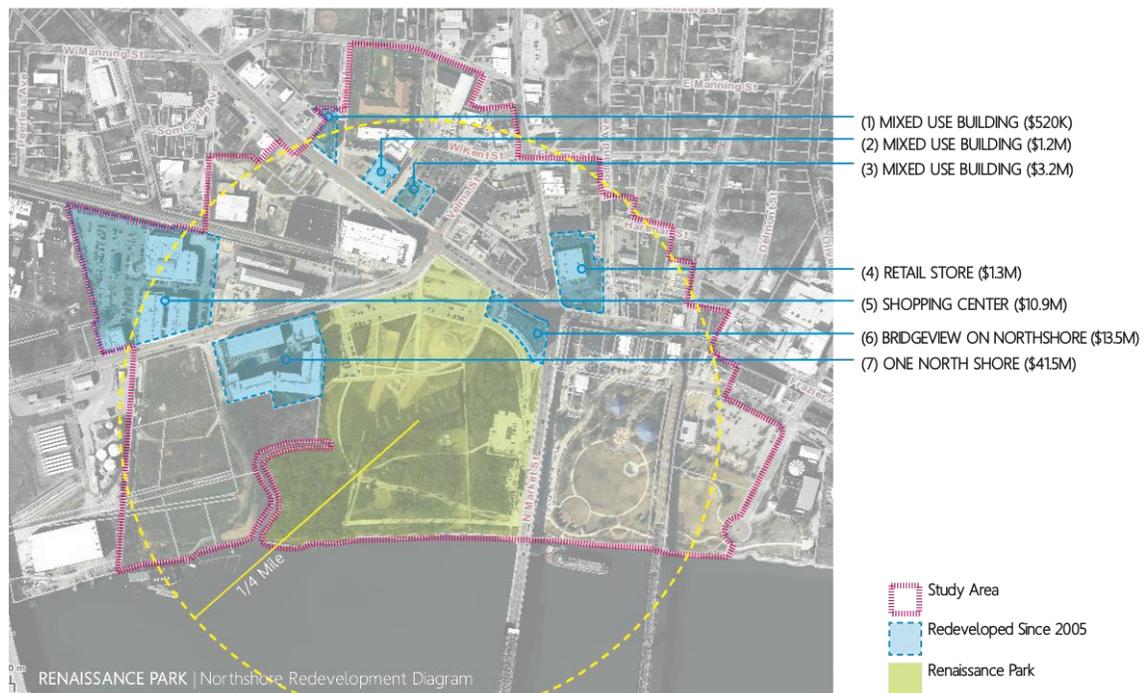
Figure 18: Renaissance Park Study Area

Inspecting aerial photography dated 2003 and 2013, five additional redevelopment projects were identified within the identified study area (Figure 18). These redevelopment projects were confirmed by the City Land Development Office to include two retail projects and three mixed-use developments.

An analysis of historic data from the Hamilton County assessor’s office (Figure 19) revealed stable land values within the study area (Figure 18) leading up to when Renaissance Park’s construction commenced in 2004-2005. Land values were then observed to begin increasing between 2005 and 2006 when construction at the park was complete. Figure 20 shows the results of the analysis of this data, representing value change between 2000 and 2013. Figures shown are aggregated appraised values. A 821% increase in the aggregate land value of 338 properties within the study area was observed between 2005 and 2013. This growth was benchmarked against the 319% increase in the aggregate land value of the 973 parcels within the North Shore Neighborhood that are outside of the study area during the same period.

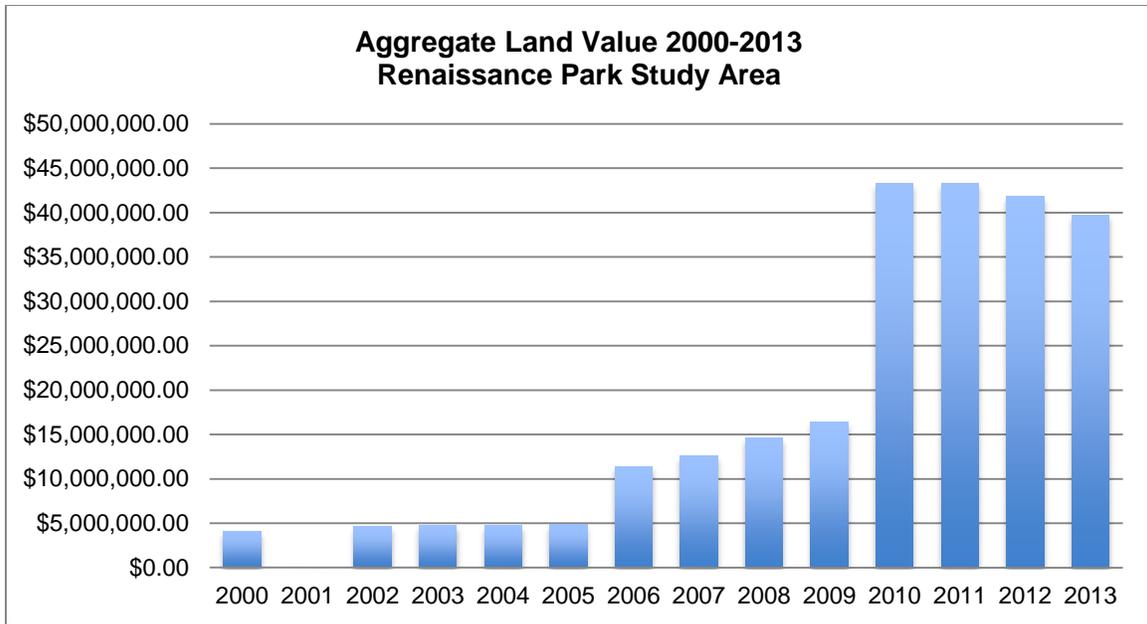
Figure 20

A significant spike is noticed in the study area aggregate land value between 2009 and 2010. 2010 is the first year in the county tax records that the 245 retail and residential condominiums in the One North Shore and Bridgeview On North Shore properties are reflected in tax records. Each condominium then carries a pro-rated value of the property's total value, and the land value for the parent property is reduced accordingly.

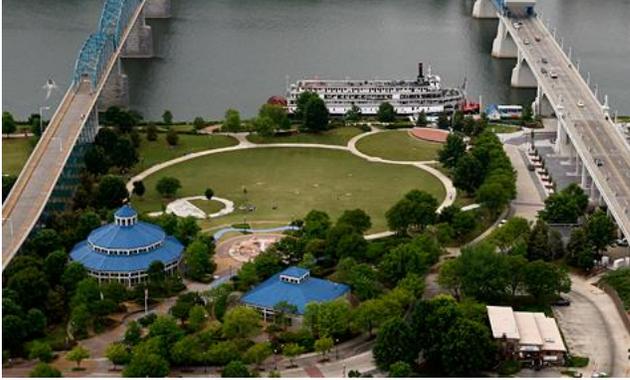
Figure 24. Coolidge Park
Staff Photo by Doug Strickland/Chattanooga Times Free Press, April 20, 2012.

Aerial photographs of the two parks illustrate the difference in park style (Figures 23 & 24):

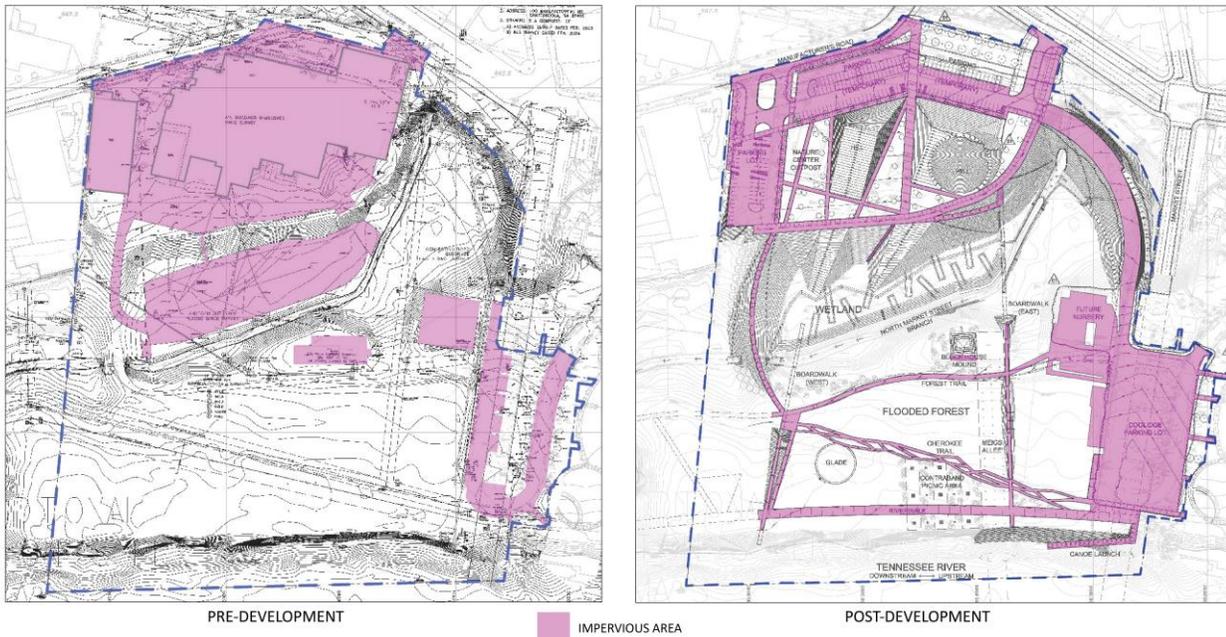
Figure 25 shows the pre and post development impervious areas. Adjustments were made to account for the difference in as-built conditions compared to construction drawings by viewing aerial photographs in Google Earth.

PDFs of construction documents of existing site conditions and proposed redevelopment were brought into AutoCAD. Impervious areas of the pre-development conditions were identified and outlined with the polyline tool. These areas were calculated with the area tool and added together. Pervious areas of the new park site were delineated and quantified using the polyline tool, then subtracted from the overall impervious area, also delineated and quantified with the polyline tool. The percent difference in impervious area was calculated as shown below:

Industrial site impervious area:	382,207 sq ft
Park overall impervious area:	301,849 sq ft
Difference:	80,358 sq ft
% difference = 80,358 sq ft/382,207 sq ft = 0.21 or 21%
